# Performance Assessment and Actual Operational Maintenance Needs (AKNOP) of Situ Ranca Gede Kawao, Serang Regency

Rachmad Aditya Caesar<sup>1\*</sup>, Moh. Irfan Al Anshori<sup>1</sup>

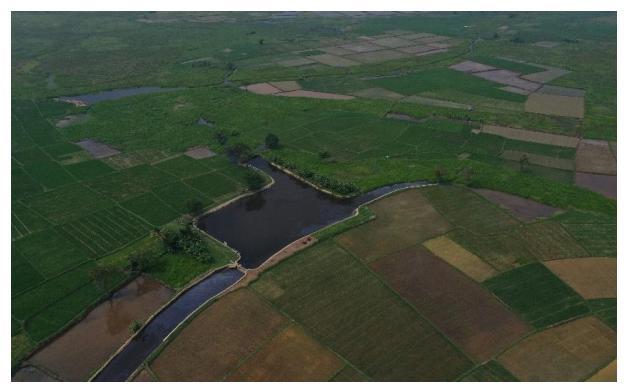
Fig. 4. Location of Routine Maintenance for Tree Cutting and Grass Cutting

Table 9. Routine Maintenance Costs of Situ Ranca Gede Kawao				
Component	Unit	Volume	Unit Price (Rp)	Total Cost (Rp)
Tree Cutting (Clearing)	m²	1002	9,853	9,872,706
Grass Cutting	m²	253	883	223,457
Solid Weed Cleaning	m³	315	98,530	31,036,950
Painting	m²	13.50	59,253	799,924
Door Lubrication	Unit	12	26,156	313,880
			Total Cost	42 246 918

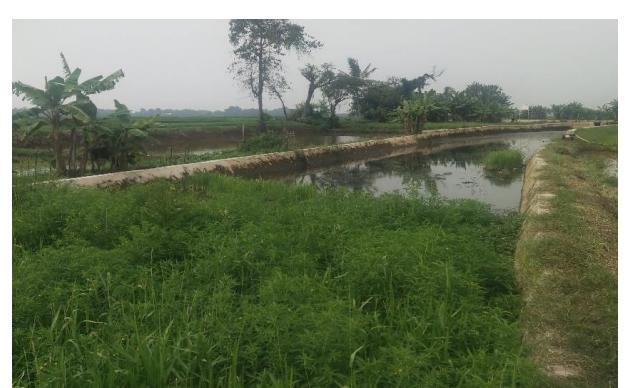
Fig. 5. Solid Weed Cleaning

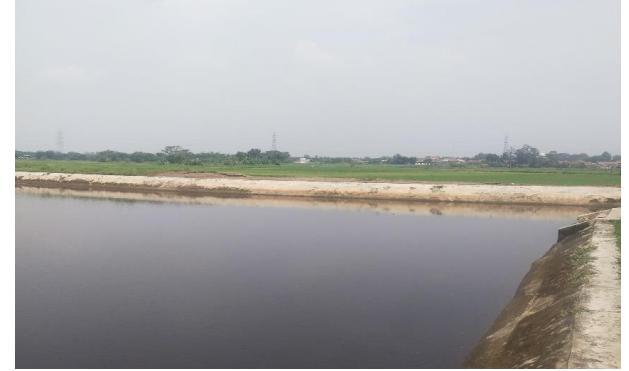
In general, the physical infrastructure of Situ Ranca Gede Kawao is in good condition. Sedimentation remains the primary issue for the site. Minor damages also occurred to the situ lining over a 100-meter stretch (Figure 6) and the washing staircase over 3 meters (Figure 7). The damage to the lining has caused leaks, resulting in reduced water supply for agricultural land. The periodic maintenance costs have been prioritized for the repair of the situ lining, as this is a critical component of the site.

Fig. 6. Damage to Situ Lining

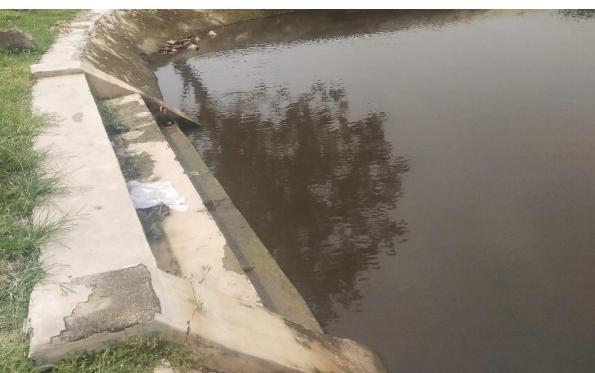
Fig. 7. Damage to Washing Staircase
