# EULER BUCKLING FAILURE MODEL AT GALVANIZED PIPE INFLUENCED BY HOLE DETERIORATION AS PITTING CORROSION MODELLED EXPERIMENTAL APPROACHMENT

**Miftahul Iman**

Jurusan Teknik Sipil Fakultas Teknik Universitas Borneo Tarakan  
email: miftah@borneo.ac.id

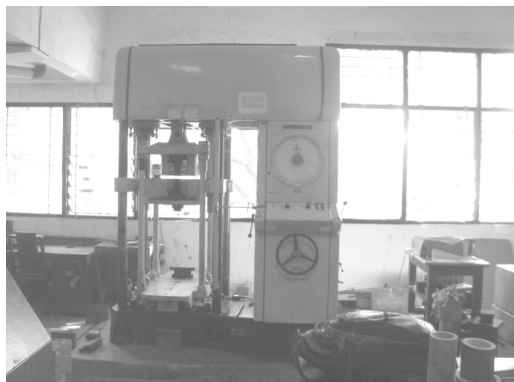
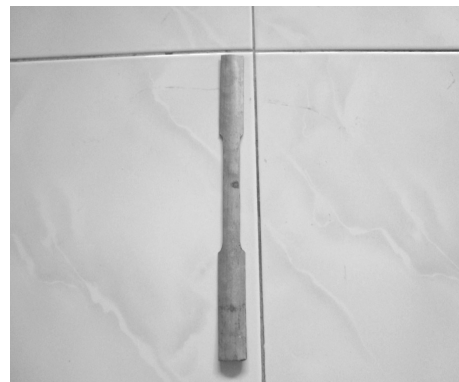
Figure 1. Tension Test by UTM Every Denison and The Speciment

UTM “Every-Denison” powered by electricity power which every load carried on will be showed by pointer in kilo Newton units. The number was shown must be multiplied by 0,05 as calibration factor to produce axial load force at speciment (Figure 1(ii)). This equipment was also completed by extensometer to determine elongation of the speciment. The value of elongation must be multiplied by 0,001 as calibration factor to get the accuracy.

Pre test have done to evaluate elasticity modulus (E) of galvanized pipe STR 24 by tension test. Universal Testing Machine (UTM) Every Denison were used to observe stress and strain of the speciment by tension test.

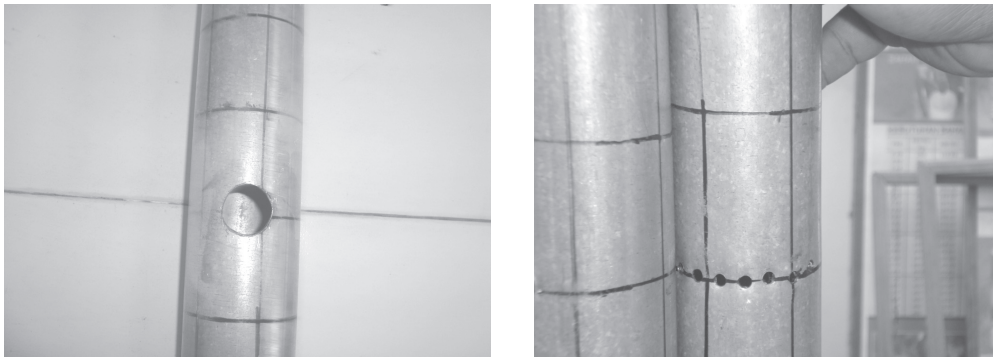
Figure 2. SHP and MHP Samples of Galvanized Pipe with Hole Treatment

Figure 2 shows the samples (SHP and MHP) were used in this project. The sample laid on pinned-pinned supported vertically. The bottom of the sample load cell 2 T and 5 T capacity were put and powered by hydraulic jack for loading transfer mechanism as shown as on experimental setting scetch below:

16 Galvanized pipes 2,0 inch were prepared for the sampel with geometric specification such in outside diameter = 56,02 mm; thickness = 0,81 mm; and length = 2500 mm.

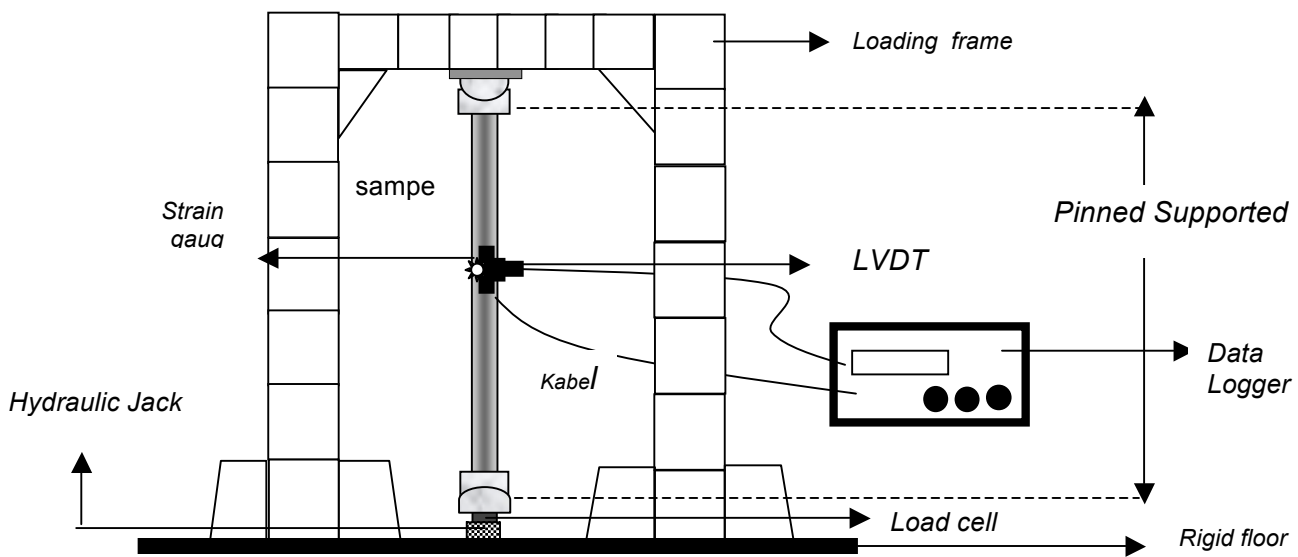
Figure 3. Compressive Setting Test

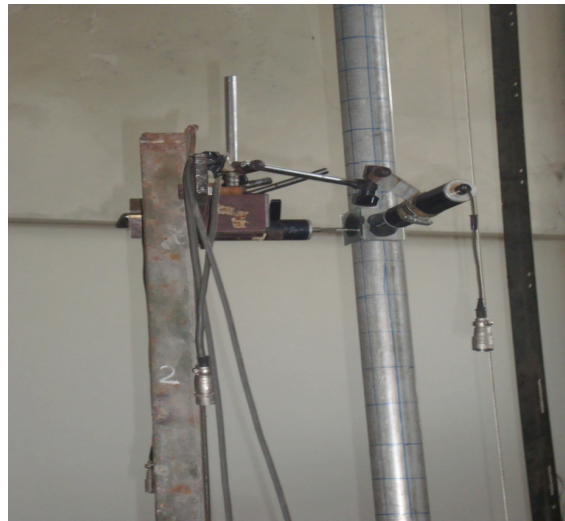
Linear variable differential transformer (LVDT) were put on angle hand into length of sample at the mid span that were supported by a couple of glasses with alumunium covered to control the displacement as shown as the figure below:

Figure 4. LVDT Setting

The function of a couple glasses to make stable position of LVDT considered cross section geometric effect as shown as Figure 4.

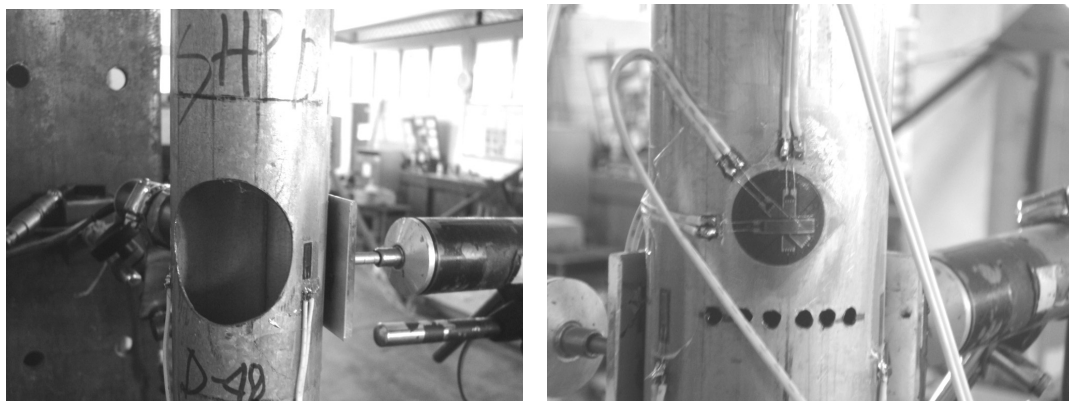
Strain gauges were also put on middle span of sample especially at maximum tension area were supposed and severe area at surround of the holes. Rectangular rosette strain gauges were also used in this research to investigate the stress concentration close into the holes. Load cell, LVDT and strain gauge were connected by data logger as data recording.

Figure 5. Strain Gauge Setting

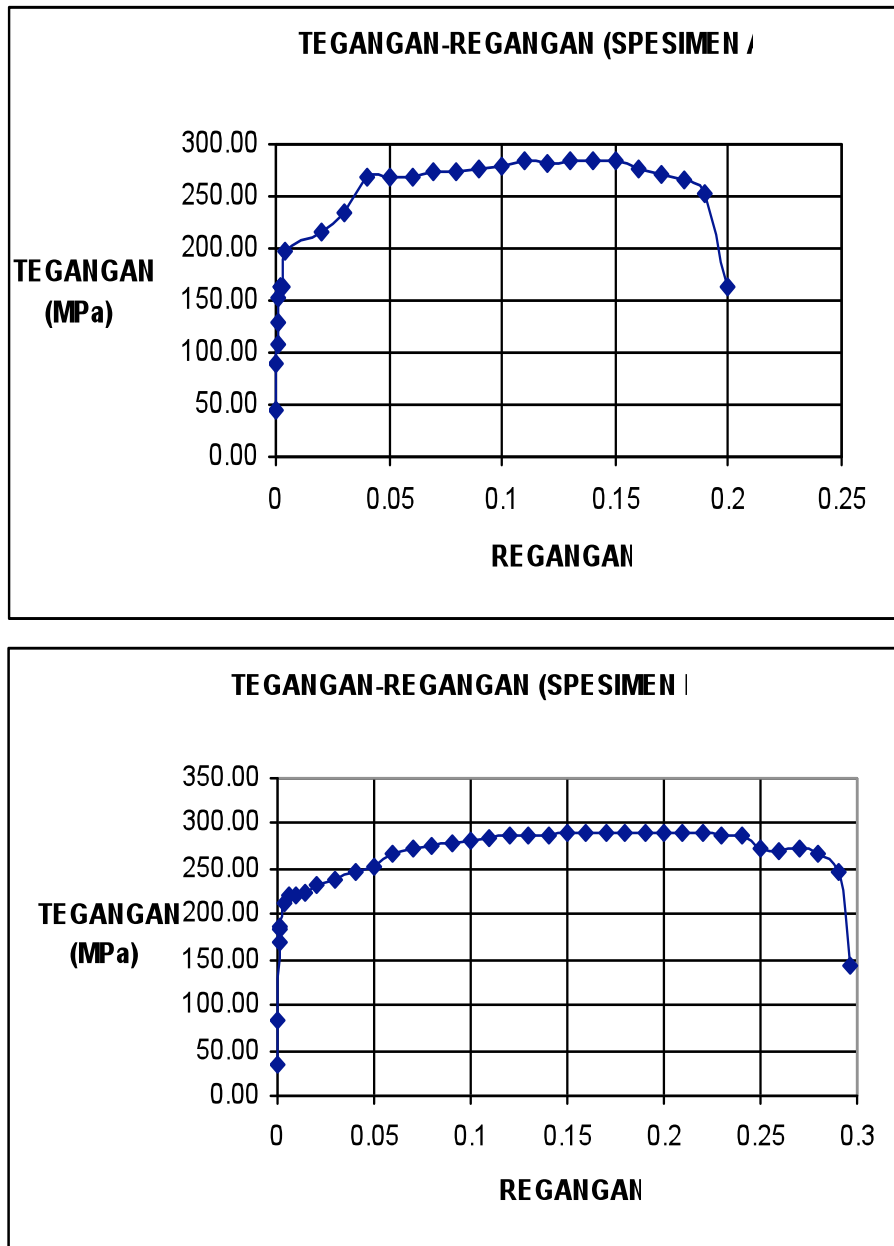
Figure 6. Stress-Strain Curve of Galvanis Pipe Tension Speciments

Figure 6 shows that the value of E correspondently for each speciment are 185185 Mpa and 249383 Mpa where the average value of E will be used 217284 Mpa. Speciment performance (plan or shell) need suit gripping tools of UTM. Hence slice and failure at the unexpected area can be avoidable<sup>[6]</sup>. There are scetch of speciment and gripping were completed by extensometer as shown as the figure 7 below:

Tension test result shows that stress-strain relation as shown as Figure 6 below:

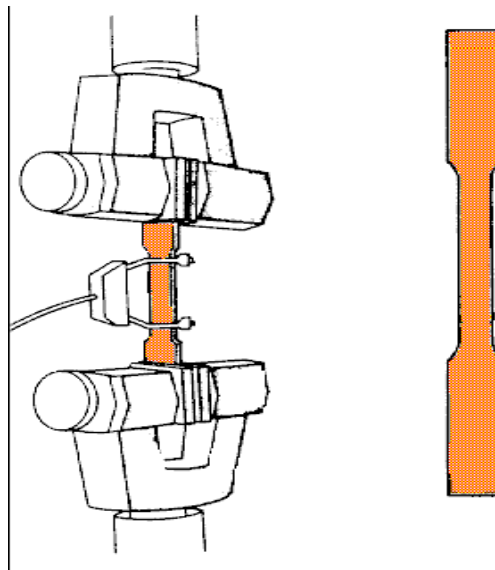
Figure 7. Specimen and Gripping

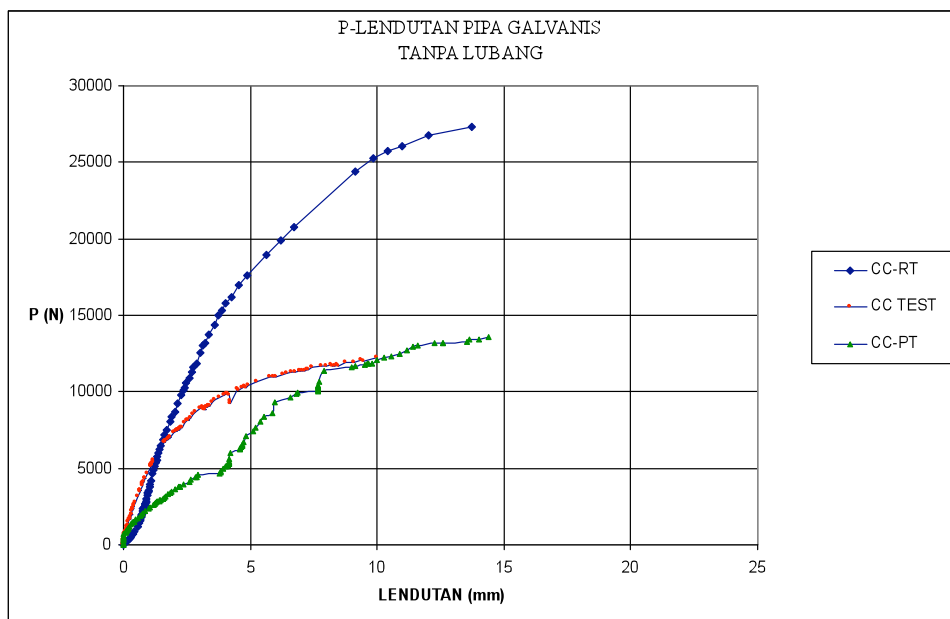
Figure 8. P-deflection laboratory test

The different value of  $P_{cr}$  showed at Figure 8, especially we have an extreme difference stiffness that were indicated by slope of the P-deflection curve. The differences were caused by:

The result of three galvanized pipes compression load test without hole treatment (called control column) as shown as the figure 8 below:

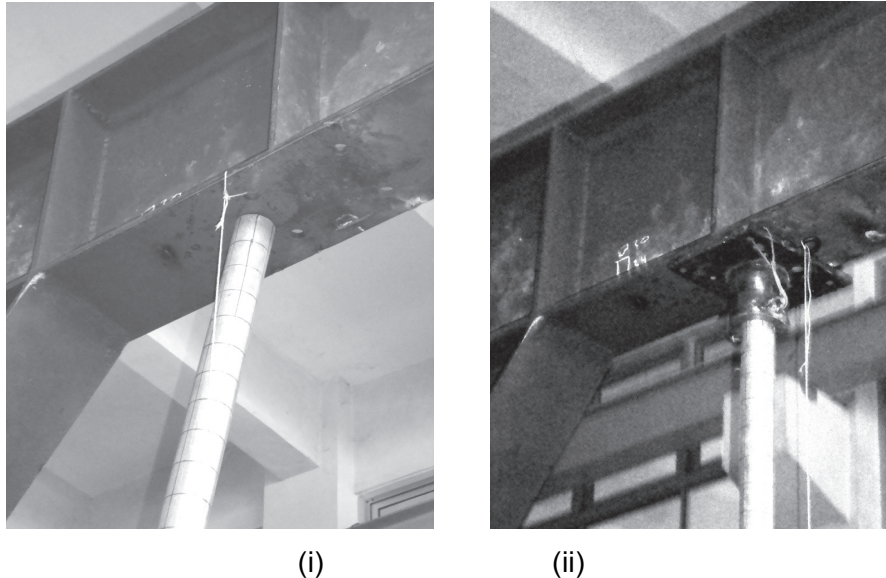
The top of the pipe supported by loading frame only without any treatment to model pinned-pinned supported as shown as Figure 9 (i). This setting give translation and rotation effect of the supported was disturbed, in another word translation and rotation of the support does not give translation and rotation of pinned-pinned supported. Pinned-pinned supported was designated to be model in this research (Figure 9(ii)) so be able to get perfect rotation and minimize translation effect if the member loading carried on. This type of supported made the stiffness higher than two cases of compression load test before.

Gambar 9. Pengujian tekan kolom control

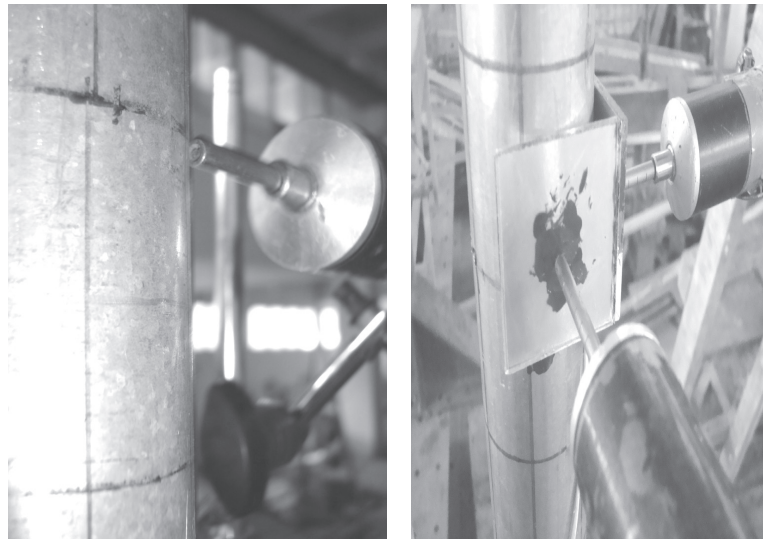
The LVDT setting up need to be evaluated because of the fault setting up of LVDT will give miss information about the displacement. We have circular cross section sample and it can be possible slice was occurred at LVDT. Another meaning we have incorrect measurement of displacement occurred. The angle hand position of LVDT were expected to give linear vector resultant of displacement occurred. In the fact the buckle orientation is unpredictable that showed inconsistence the read of LVDT. Using a couple of glasses is one of effort to have stable position of LVDT as shown as the figure 10 however this is not effective way in severe case, especially for the sample with in artificial holes treatment. Example we have some MHP that orientation buckle contrary moved in unexpected direction and made glasses broke.

Figure 10 LVDT Setting Up

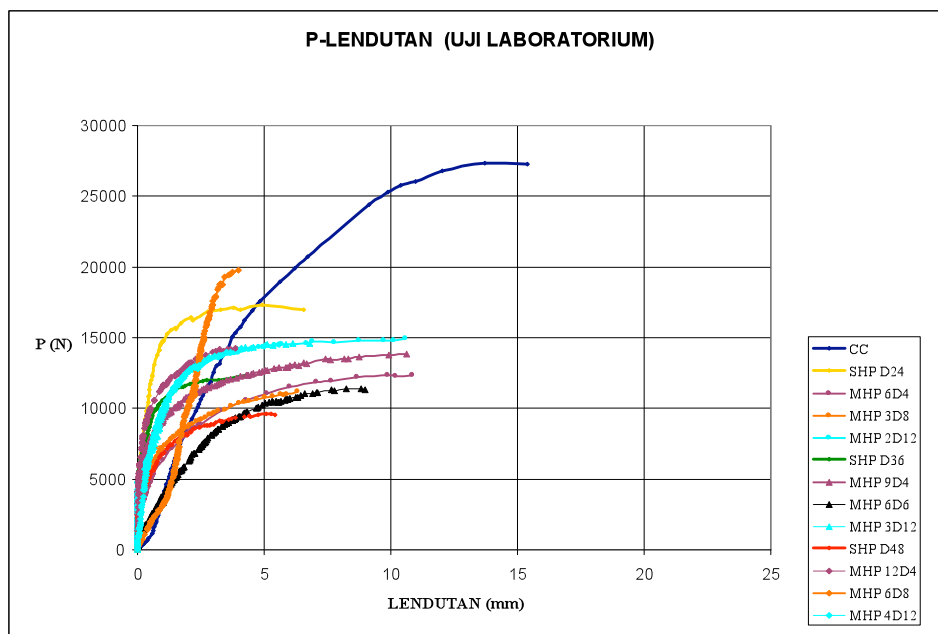
Figure 11. P-deflection laboratory test

Figure 11. showed size ncreasing of diameter of artificial hole caused lower Pcr achievement. Pcr for sample MHP higher than Pcr for sample SHP. However rate of load, control LVDT and no observation at shortening member caused some uniques phenomenon in this project. The value of Pcr SHP D24 and MHP 6D8 are too high relative than the other samples and stiffness effect is one of them. This experiment has been verified by numerical analysis utilize SAP 2000<sup>[3]</sup> below:

All of the result test showed that buckling failure occurred as like as a truss member get the compression load carried on both of its edge. The criteria of this failure we called geometric failure that is way we always have critical load lower than yielding load of material (*instability elastic buckling failure*). This research was focused in elastic buckling failure and the P-deflection of the test showed below:

Figure 11. showed that increasing of size of artificial hole so we have the lower stress. All stress occurred in tension area lower than yielding stress off material. Hence this situation indicated that buckle occurred at load smaller than yield load.

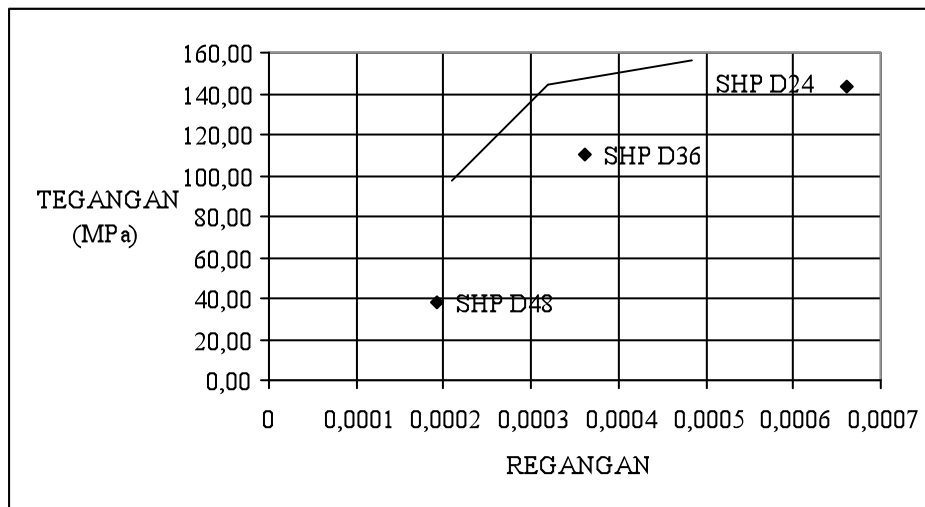
Figure 12. Stress of SHP sample
