Electrical Resistivity Tomography as a Geotechnical Justification Support in a case Makassar – Pare-Pare Railway Bed Construction KM 68+450 to KM 68+750

ABSTRACT

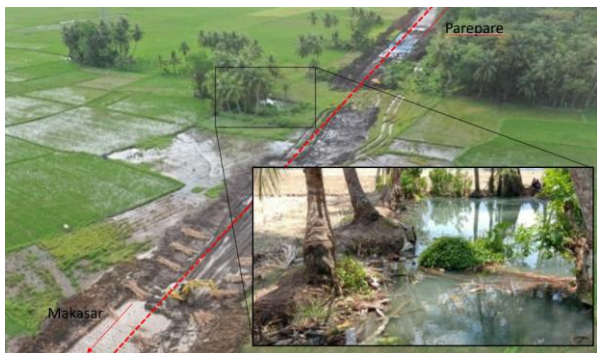
Figure 1. Reservoir at research site that suspected to be a sinkhole

remains consistently wet, forming patterns in various areas. Additionally, a reservoir, believed to be a sinkhole, was also observed, as shown in Figure 1. The geological conditions of karstic/limestone bedrock locations, such as this research area, can result in subsurface flow and sinkholes. A sinkhole disaster occurred previously in Maros, approximately 40 km from the research site. That sink hole suspected to be the result of an underground river's former flow [1]. Limestone often contains cavities that can serve as water channels, commonly known as underground rivers. This is what underlies this researcher's identification of whether there are underground water channels on the Makassar-Parepare railway line at KM 68+450 to 68+750, which can endanger the construction of the railway.

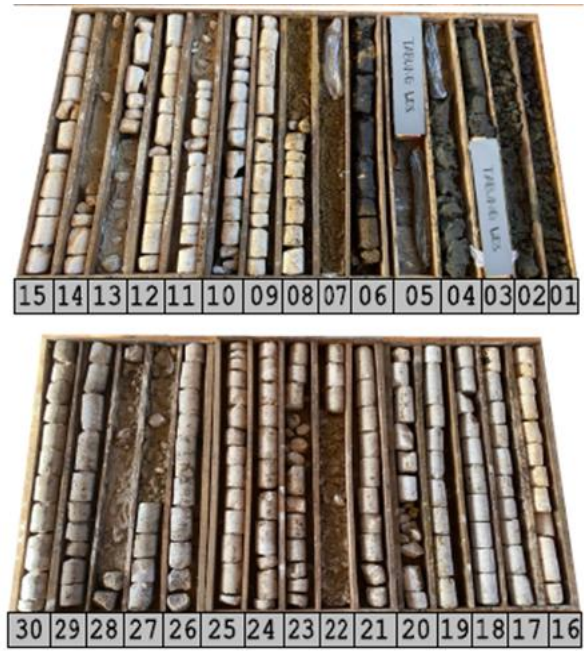
Figure 17. BH1 Borehole log

The results of the BH 1 test at a depth of 7.4 m from the original soil only found limestone as the base rock. A soil layer as thick as 7.4 m mainly consists of clay with a little fine sand, following alluvial deposits' characteristics. The N-SPT value was obtained relatively low in the soil layer in BH 1, ranging from 3-10. This indicated that the soil

layer was quite soft. In the investigation > 7 m, limestone rock structures were obtained with varying conditions. In the core box samples obtained, white rocks (limestone) were crushed into powder; some were intact and weathered, and some were hard. This follows the characteristics of the type of limestone rock where the surrounding physical and chemical processes influence the hardness and integrity. In general, the results of the BH 1 test are in line with the results of the ERT test, where the surface layer is dominated by a fine-grained layer of clay and fine sand. The second layer transitions between sedimentary soil and rocks; the third layer is limestone.

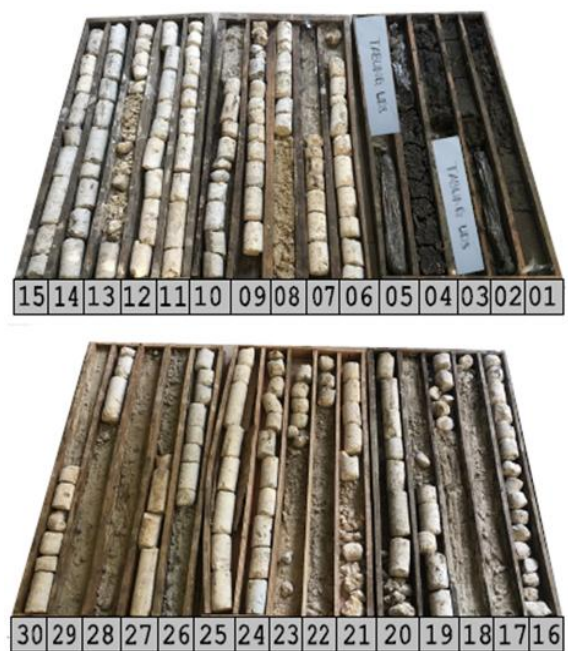
Figure18. BH2 Borehole log

Similar to the test results on BH 2 at a depth of 5 m from the original soil, limestone bedrock has been found. On the surface layer of this soil, most of the material was clay mixed with fine sand with SPT values of 2 and 3. The small SPT value indicated that the density of this soil layer was quite soft. The rock layer was the same as the results of the investigation on BH 1, where the bedrock is limestone with varying levels of weathering and hardness. For BH 1 and BH 2, the rock layer obtained an SPT value of >60, which means that the layer is indeed rock. If referring to the SPT value, the rock will get an SPT value of >60. One method to determine the rock mass quality from this Boring test is by reading the RQD value. Rocks with an RQD value <20% are often defined as rocks with inferior rock mass quality, and an RQD value of >50% is only considered good. In general, the results of the BH 2 test were in line with the results of the ERT test, where the surface layer was dominated by fine-grained layers of clay and fine sand. The second layer transitions between sedimentary soil and rocks; the third layer was limestone.
