GTAW Welding Repair Quality Analysis on Sparger Header with Liquid Penetrant and Leak Test

Header Sparger

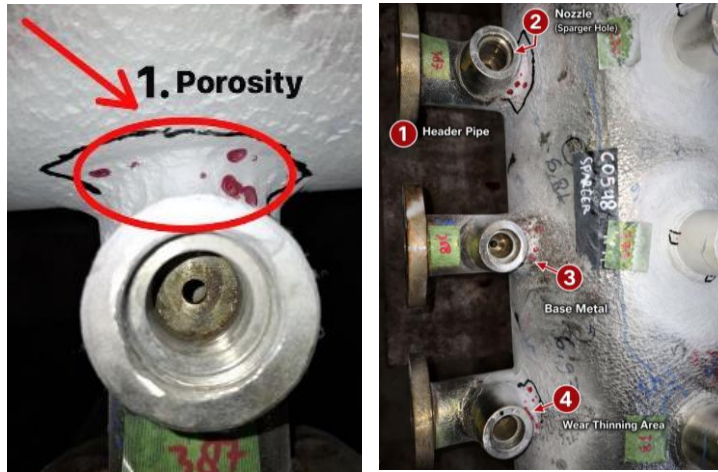
The LPT examination identified surface-breaking indications in the weld area of the sparger header RE-C215, confirming the presence of localized surface discontinuities. These indications correlate with leakage observed during field inspection, indicating compromised surface condition as shown in Figure 2.

Figure 2. LPT results showing surface indications on the weld area

The detected damage is characterized by localized wall thinning, which is typically associated with corrosion and/or erosion mechanisms under continuous exposure to process fluids. Such degradation leads to a progressive reduction in effective wall thickness, resulting in increased stress concentration and a significant decline in the pressure containment capability of the component. As the wall thickness decreases below the design allowance, the component becomes more susceptible to leakage and potential failure under operating pressure. This degradation mechanism has been widely recognized as a critical failure mode in pressure-retaining equipment operating in corrosive environments (Song et al., 2023), particularly in systems subjected to long-term chemical exposure and elevated temperatures.

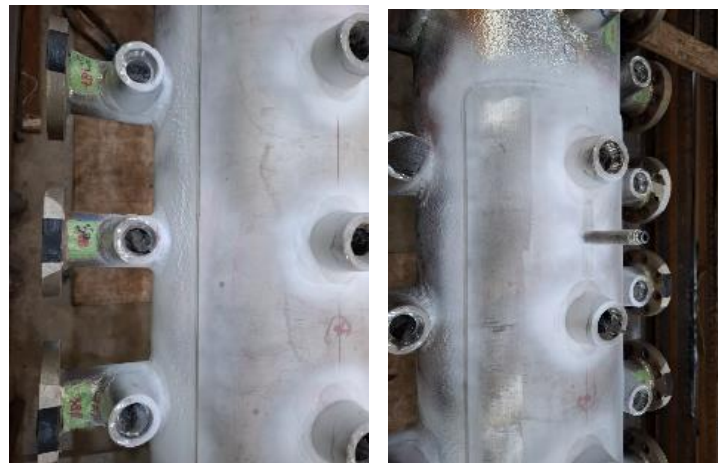
The Liquid Penetrant Testing (LPT) results identified no surface-breaking indications in the repaired weld area of the sparger header RE-C215, demonstrating that the weld surface satisfies the specified acceptance criteria, as shown in Figure 4. This result indicates that the repair welding process successfully restored the surface integrity of the component. The absence of detectable indications suggests that critical surface defects such as cracks, porosity, and lack of fusion were effectively minimized during welding.

Figure 4. Liquid penetrating testing results of the repaired sparger header

Welding defects are generally associated with improper parameter selection, inadequate shielding, and contamination during the welding process (Rizvi & Alib, 2019). In this study, the controlled application of GTAW parameters, combined with proper surface preparation and interpass cleaning, contributed to stable arc conditions and reduced the likelihood of defect formation. This finding is consistent with previous studies (Xie et al., 2022), which reported that appropriate control of welding variables significantly improves weld surface quality and reduces defect occurrence.

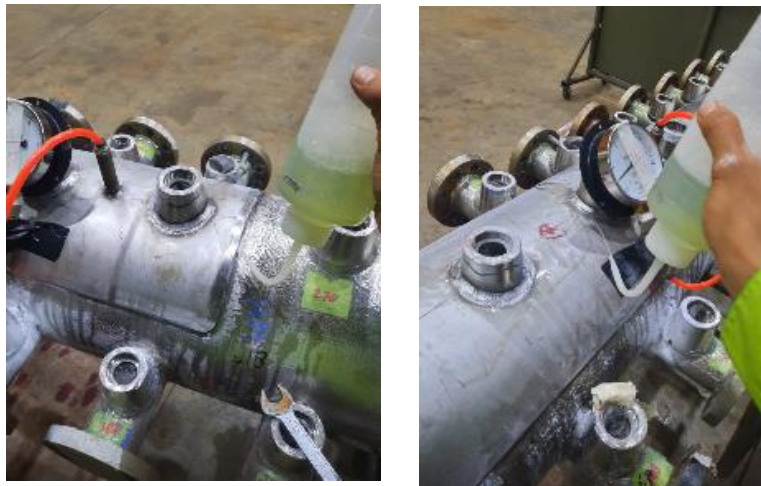
Leak testing was conducted to evaluate the sealing performance of the repaired welded joint under pressurized conditions, as shown in Figure 5. (Zygmuntowicz et al., 2021). The test results demonstrated stable pressure conditions with no evidence of bubble formation or fluid seepage throughout the holding period, indicating that the repaired weld achieved adequate leak-tightness performance. This confirms that the welding process successfully restored the pressure-retaining function of the component.

Figure 5. Leak testing setup/result of sparger header RE-C215

Testing Parameters	Average value	Standard	Results
Leak Testing Pressure	1.2 kg/cm ²	≥ 1 kg/cm ²	Pressure achieved and stable
Holding Time	37 minutes	≥ 30 minutes	Test time met standards
LPT Results	-	No Indication	No surface defects found
Leak Testing Results	-	No Indication	No bubbles, no seepage
