# The Mechanism of Rainfall-Induced Landslide Around Railway Tracks in Central Java Province, Indonesia

Ika Sakti Octaviarini<sup>a\*</sup>, Teuku Faisal Fathani<sup>a</sup>, Hary Christady Hardiyatmo<sup>a</sup>, Anisa Nur Amalina<sup>b</sup>, and Egy Erzagian<sup>a</sup>

<sup>a</sup> Department of Civil and Environmental Engineering, Faculty of Engineering, Universitas Gadjah Mada, Yogyakarta 55281, Indonesia

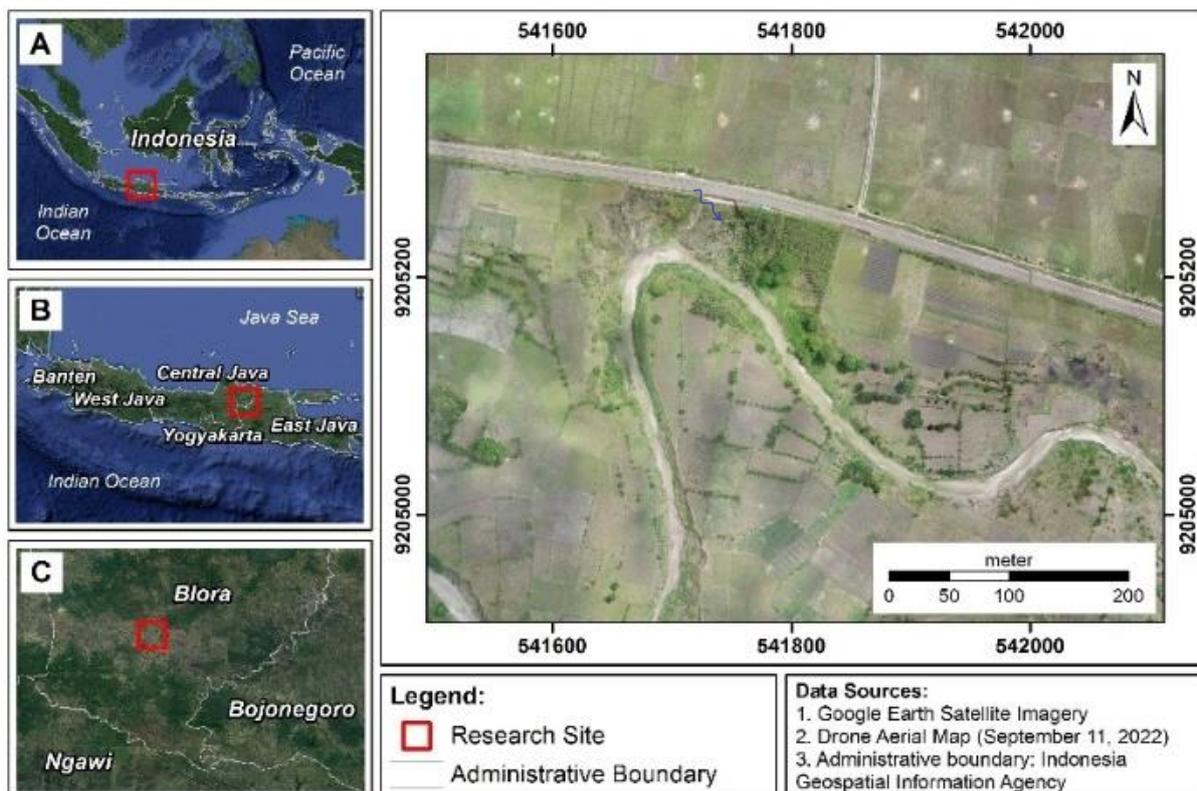
A landslide was reported on the southern side of the double-track railway in Central Java Province shown in Figure 1. The landslides occurred gradually from January to June 2022. However, the landslide that occurred in June

Figure 1. Study area.

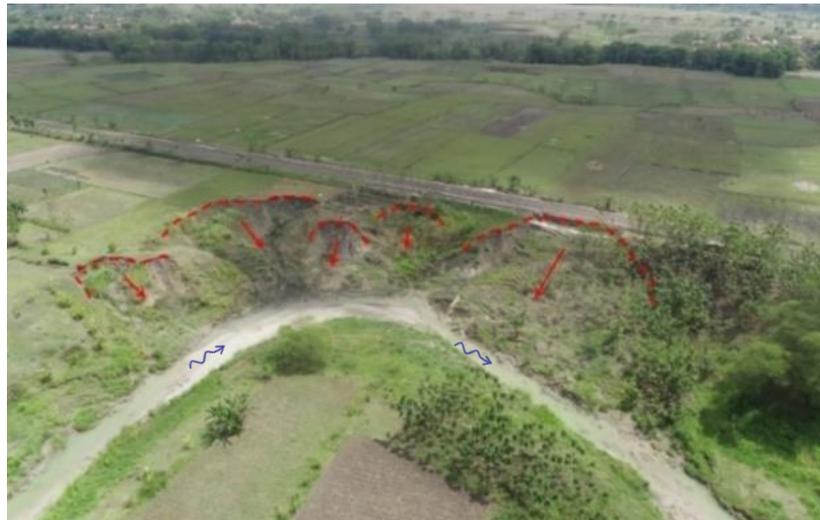
2022 had the most significant impact, causing subsidence on the railway tracks, especially on the southern side. The occurrence of the landslide resulted in the disruption of train operations, as the train had to operate below the operational speed when passing through the landslide area. The trains operating speed under normal conditions reached 110 km/hour, but after the landslide occurred, the speed of passing trains had to be reduced to 60 km/hour for the northern railway line and 20 km/hour for the south. The landslide had a crown with dimensions 38 meters long and 12 meters high, and the coverage area reached 984 m<sup>2</sup> shown in Figure 2. Its movement mechanism was rotational sliding with landslide material consisting of a mixture of soil, sand, clay material, and vegetation.

Figure 2. Landslides in the study area.

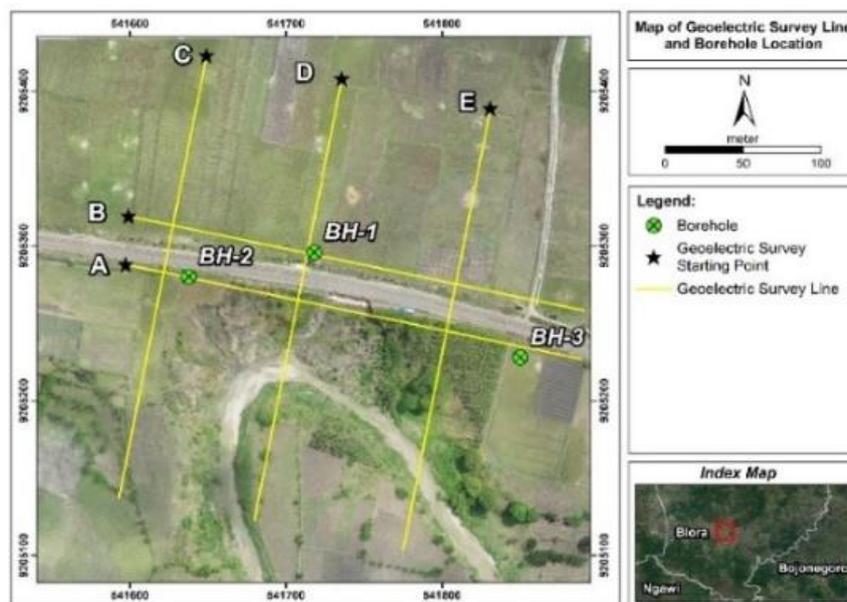
Soil investigation was carried out at the study area using the standard penetration test method and soil sampling for further laboratory testing to determine soil engineering properties, as seen in Figure 3. There were also five geoelectrical testing lines. The geoelectrical survey is a method for interpreting the characteristics of rock and structure below the soil surface by utilizing electrical properties.

Figure 3. Geoelectrical line and borehole point map.

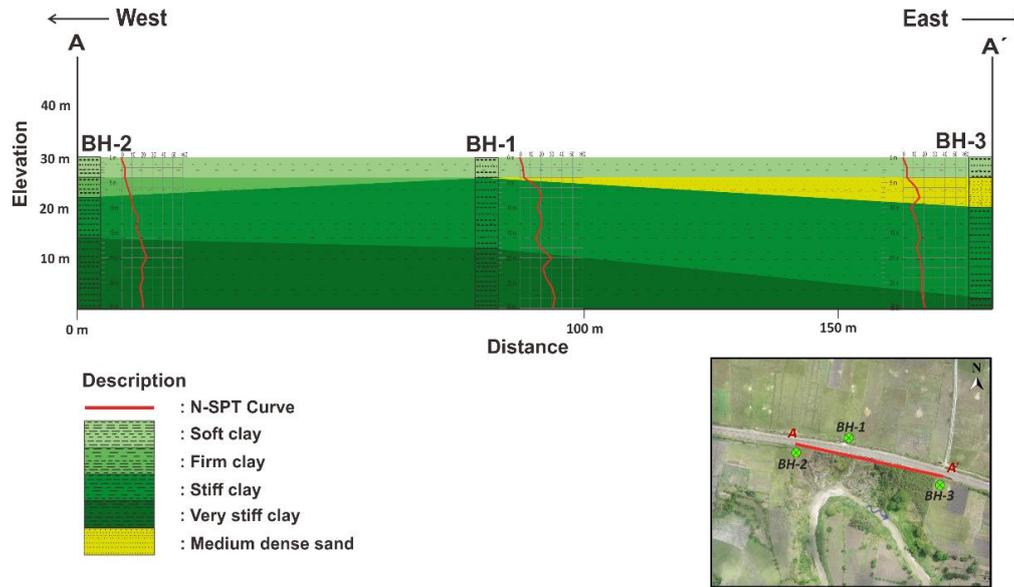
The SPT results indicated that the soil layer was predominantly composed of clay with an N-SPT value of less than 30 up to a depth of 30 meters at all three locations. The clay layer had a consistency ranging from soft to very stiff. A longitudinal soil stratigraphy was made through the three borehole points (lines A-A') to determine the subsurface layering at the study area shown in Figure 4.

Figure 4. Soil stratigraphy.

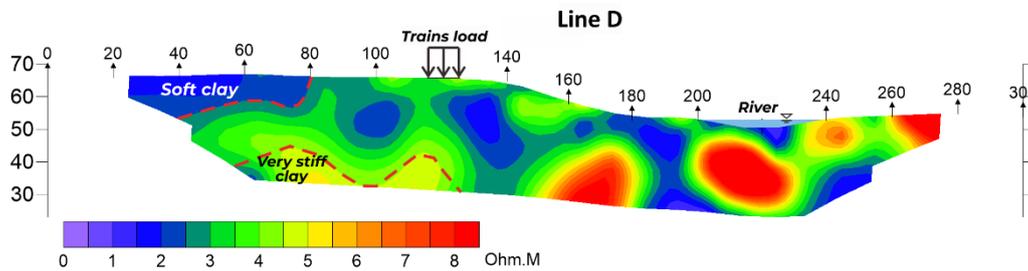
The zones that encounter landslides are indicated by line D which extends for 240 m (north-south) with the location of the borehole point (BH-1) at a distance of approximately 100 m. In general, the type of soil based on the resistivity cross-section on path D consists of three types, namely soft clay (about 2 ohm.m), stiff clay (3 – 4

ohm.m), and very stiff clay (>5 ohm.m). The grouping of soil types is correlated with the results of borehole testing so that geoelectric data can support the results of borehole data interpretation. The landslide area has surface soil that is dominated by soft clay where these zones are described with low resistivity values (about 2 ohm.m) which are soft clay. This follows the theory of the geoelectric method that the landslide zone will occur in a medium with a low resistivity value.

Figure 5. Geoelectrical survey results at line D.

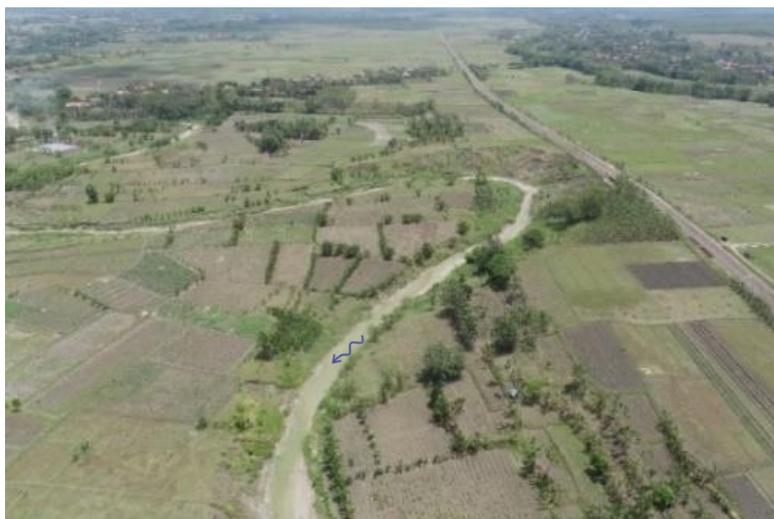
The study area is the downstream part of the perennial river of the Jampi River and a tributary river of the Lusi River in the northwest shown in Figure 6. The river valley is located south of the main rail line and is classified as an old stadia. According to [22], the mature to old stadia areas are characterized by rivers in this section dominated by "U" shaped valleys and show indications of lateral erosion, which are slow but more dominant than vertical erosion. This is also supported by evidence of a lateral shift of river water flow.

**Figure 6.** River conditions in the study area

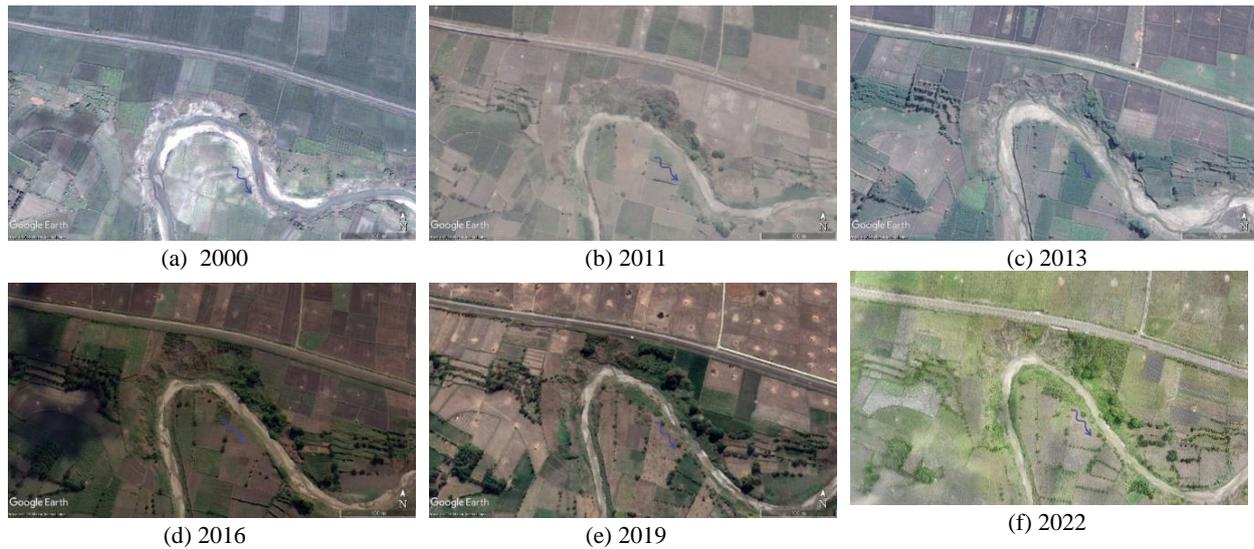
Based on the results of a comparison between aerial photographs and available Google Earth satellite imagery, information is obtained that the river bends are being naturally displaced. Changes in the river bend from 2000 to 2022 can be seen in Figure 7. In 2000, the riverbank was  $\pm 50$  m south of the railway tracks. The shape of the river bend has shifted, tapering more and more to the north, causing the riverbank to move closer to the railway tracks. In 2022, the riverbank will be approximately 45 m south of the railway tracks, indicating a shift of up to 5 meters north or approaching the railway tracks. Thi and Minh (2019) reported that soil erosion may cause riverbanks to become increasingly overhanging [23]. During the rainy season, the river water level rises, resulting in a high shear stress flow that expands the width of soil erosion and creates an overhanging bank shape.

**Figure 7.** Changes in river bend [24].

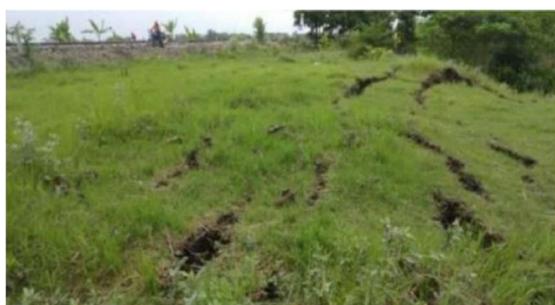
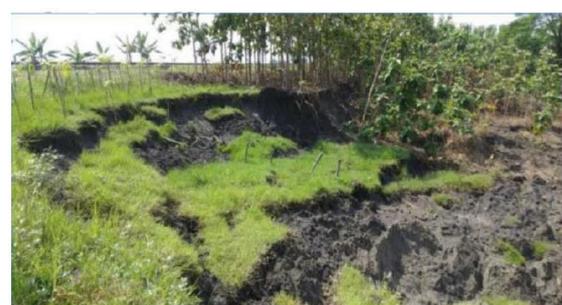
The landslide that occurred in the study area was a progressive landslide, with tension cracks forming on the slope on 26 January 2022 shown in Figure 8. The cracked soil gradually became unstable and moved down the slope, resulting in a landslide on May 9, 2022. The landslide area expanded causing subsidence on the south side of the railway line on June 30. Although landslides can be influenced by several factors such as slope conditions and angle, lithology, soil type, and hydrological or

**Figure 8.** Landslide event time: (a) January 26; and (b) May 9 [29].

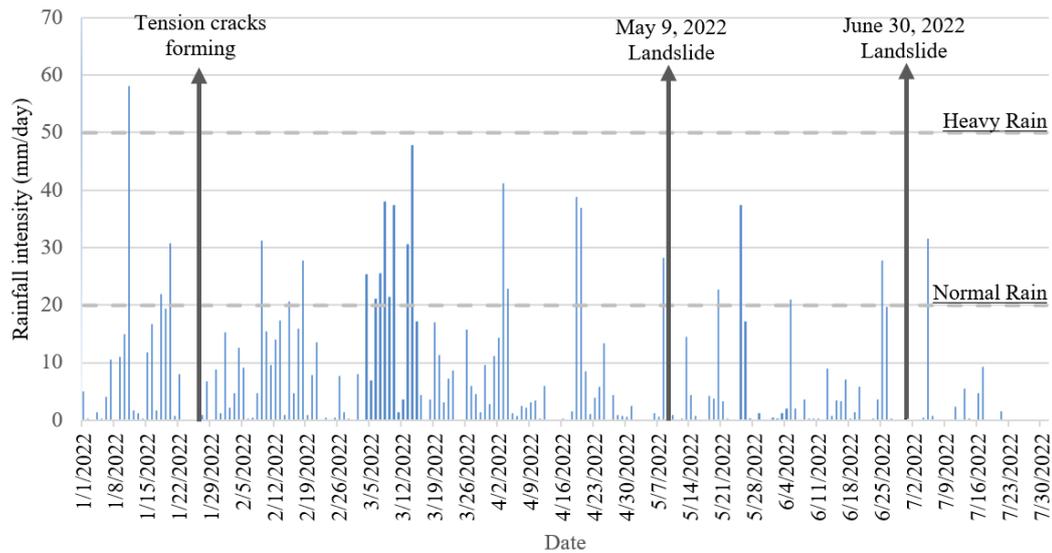
meteorological conditions [28], rainfall is considered to be the main trigger for landslides in the study area. This is because most of the landslides reported in the area occurred during months of intense rainfall. The measurement of water that falls on the ground during a specific period is expressed in millimeters (mm) through rainfall. The 2022 hourly rainfall record was obtained from meteorological stations maintained by the Japan Aerospace Exploration Agency (JAXA). Figure 9 shows the distribution of daily rainfall over 6 months in the study area.

It rained on 11 days between January 7 and January 22 with an intensity of 7.94 – 58.08 mm/day before the slope area experienced massive cracks. The total cumulative rainfall that occurred from January 1 to 25 was 220 mm, indicating a long duration of rainfall and low intensity in that period. A major landslide occurred on May 9, 2022, approximately three months after the tension cracks formed. During that period, more than 45 rainfall ranging from 6.00 – 47.84 mm/day with a rainfall duration of 1 – 11 hours were recorded.

**Figure 9.** Daily precipitation data from January to June

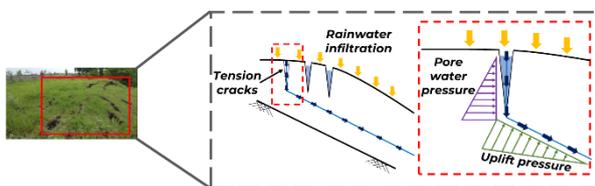
In the period after the formation of tension cracked and before the landslide occurred, more than 45 rain events were recorded with a fairly long duration. Rainwater infiltrates and accumulates in the slope through the tension cracks that form, generating lateral water pressure that creates horizontal pressure. Furthermore, rainwater infiltration contributes to the loss of suction and a decrease in effective stress, causing the soil mass to weaken and become unstable. Due to lateral water pressure, uplift pressure, and soil softening, the slip surfaces merge completely in the sliding zone and the unstable soil mass immediately collapses, which is the initiation of a landslide shown in Figure 10.

Figure 10. Water pressure distribution in tension cracks.

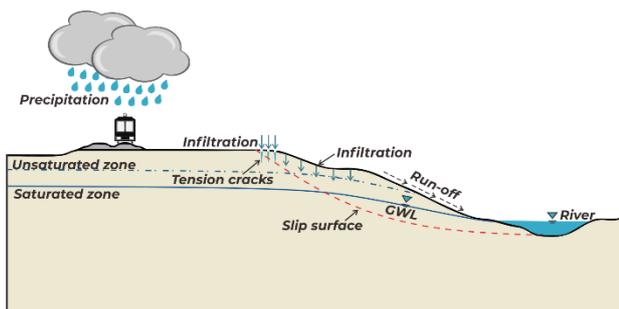
The movement of material causes the slope to become more upright and in unstable conditions. The second landslide occurred 2 months after the first landslide occurred. During this period, rain was recorded with light to normal intensity. As the rain continues to fall, rainwater will enter the body of the slope, increasing the load on the slope and causing the slope to become unstable. Rainwater that enters the soil will reduce the shear strength of the soil. This worsens the already unstable condition of the slopes. The reduction in shear strength leads to a decrease in the slope's factor of safety and subsequently triggers landslides. A schematic of the movement mechanism of slope failure in the study area is given in Figure 11.

Figure 11. The mechanism of slope failure in the study area.

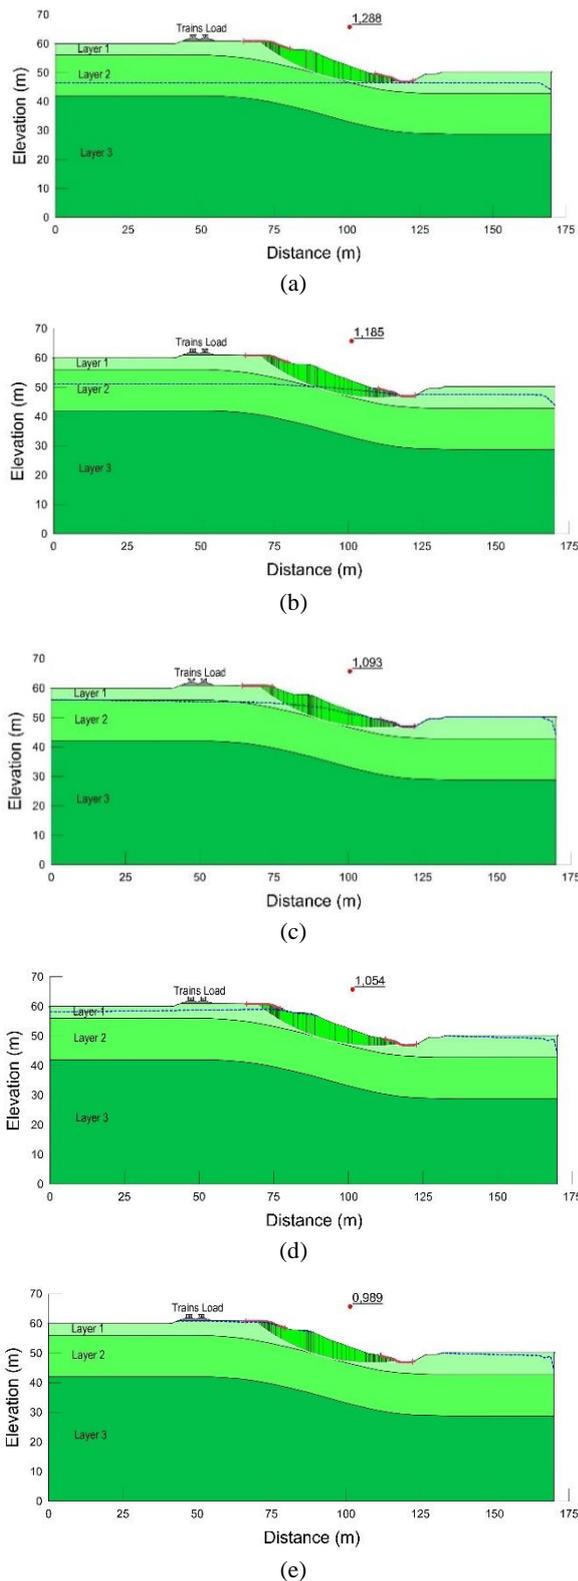
The slope stability analysis was performed with SLOPE/W using the Morgenstern-Price method. Landslide simulation was started with the slope geometrics determination at the most critical cross-section. The simulation was performed with five different groundwater level scenarios. The first simulation modeled the groundwater level below the riverbed since the river is dry during the dry season according to local conditions. Figure 12b shows the results of this simulation, which produced an FS value of 1.288. In the second simulation, the groundwater level slowly rose due to the infiltration of rainwater into the soil and reached approximately 4.5 meters above the first water level, as shown in Figure 12b. The simulation results of the second scenario produced an FS value of 1.185.

In the third simulation, the groundwater level was at a depth of 4.5 below the ground surface shown in Figure 12c. The simulation results showed a factor of safety (FS) of 1.093. However, based on Table 2, this FS value is lower than the minimum required value of 1.25, indicating a potential for landslides. This is due to the formation of tension cracks that make the slope unstable. As a result, there is a high risk of landslides. This condition is the beginning of a slope-critical condition.

In the next simulation, the groundwater level was at a depth of 2 m from the ground surface and gives an FS value of 1.054 shown in Figure 12d. It is important to note that the FS value will decrease as the groundwater level rises. In the last simulation, the groundwater level was at a critical condition or the soil was fully saturated shown in Figure 12e. The slope stability analysis results showed an FS value of 0.989 indicating that the slope had already failed and experienced a landslide. This result is in line with the field conditions where the slope is located.

Figure 12. Simulation results.

The results of the back analysis, in the form of soil shear strength, can be used to design appropriate mitigation measures for slopes that have failed. These measures can be categorized as control works and restraint works. Control works include modification of slope geometry and infiltration control during rainfall. On the other hand, restraint works include the construction of retaining walls, piles, geosynthetics, anchors, etc.
