Slope reinforcement analysis using retaining structures: a case study in a heritage temple area in Yogyakarta

Indonesia is home to numerous cultural heritage sites situated on sloping terrain, where geotechnical stability plays a crucial role in preservation and restoration efforts. One such site is a Buddhist stupa in Sambirejo, Prambanan, Sleman, located approximately 200 meters north of Barong Temple. The stupa lies on a slope with a 16.10% gradient underlain by lithosol and regosol soils of limited thickness, which raises potential risks of instability. This study aims to evaluate the slope stability conditions of the temple area and to propose suitable reinforcement designs to ensure structural safety. Field investigations, including cone penetration tests (CPT) and hand boring, revealed that the subsurface consists primarily of fine to medium-silty sand with a groundwater table at a depth of 2.5 m. Stability analyses were performed using both manual calculations based on SNI 8460:2017 and numerical modelling with PLAXIS. Two reinforcement alternatives were assessed: cantilever retaining walls and concrete sheet piles under static and pseudo-static (seismic) conditions. The r

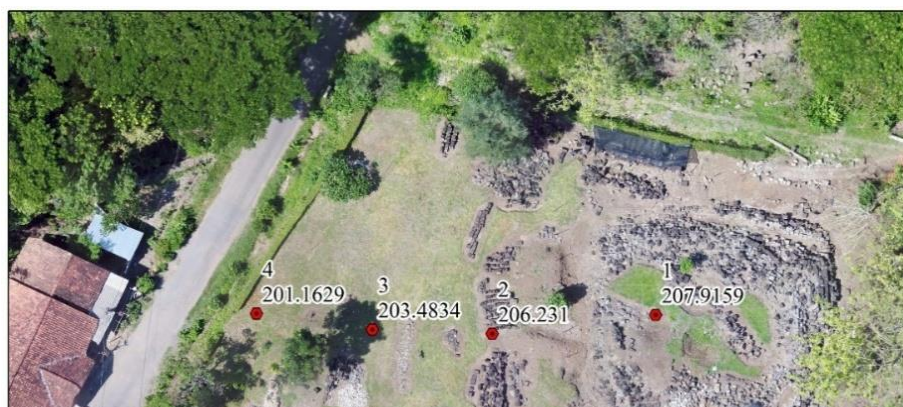
Fig. 2. Soil investigation map

In this study, a subsurface investigation was conducted using cone penetration tests (CPT) at two locations and a hand boring test at one location to obtain soil samples, determine soil hardness, and identify the thickness of each soil layer. Several points were selected to provide a representative overview of the soil type, stratification, physical properties, and relative density at the site. The site layout of the temple area and the coordinates of the field investigation points are presented in Fig. 2.

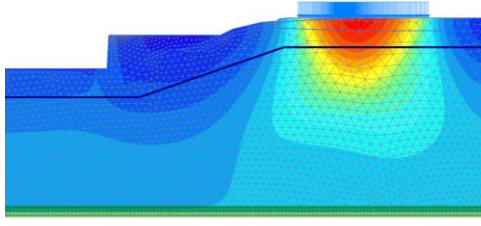
Total displacements u_y (scaled up 20.0 times) Maximum value = 0.01717 m (Element 468 at Node 21502) Minimum value = -0.05808 m (Element 162 at Node 9254) $U_y = 0.01717$

The stress distribution on the soil foundation was within safe limits, with a minimum stress of 75.99 kPa and a maximum stress of 122.40 kPa, both greater than zero. The ultimate bearing capacity (Q_{ult}) was obtained as 3888.01 kPa, significantly higher than the maximum applied stress. Consequently, the factor of safety for bearing capacity was calculated as 31.76, which far exceeds the minimum requirement of 3.0. Overall, these results confirm that the retaining wall design meets the required stability standards and can be considered structurally safe. Table 5 shows the analysis results. A subsequent global stability analysis was also conducted to assess the performance of the reinforced slope. The modelling results indicated an increase in the factor of safety under both static and dynamic conditions, as shown in Table 6.

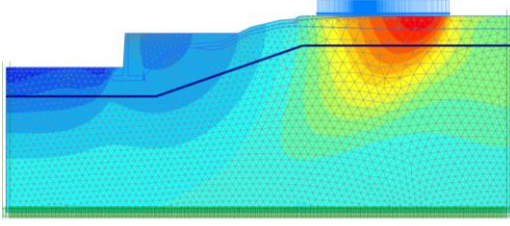
Total displacements u_y (scaled up 5.00 times) Maximum value = 0.1247 m (Element 690 at Node 36552) Minimum value = -0.2348 m (Element 76 at Node 8070) $U_y = 0.1247$

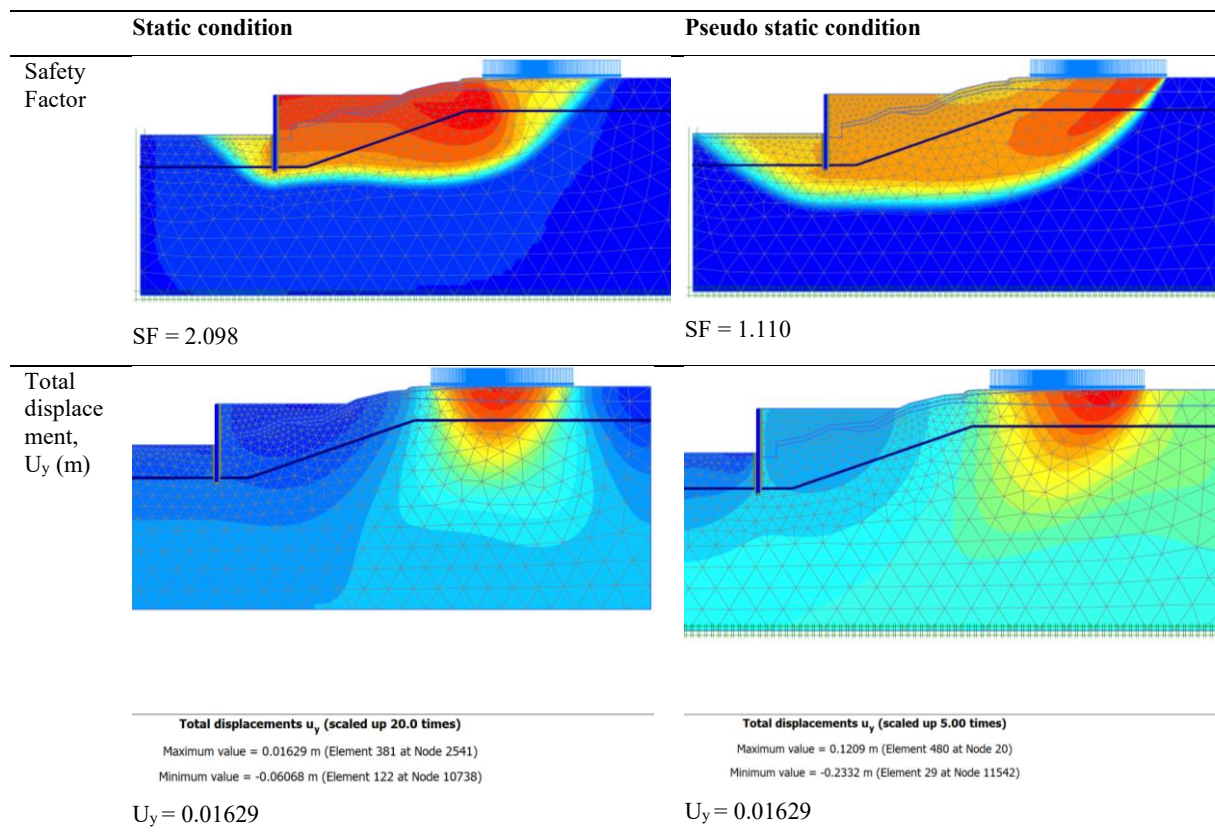
Table 8. Slope Stability Analysis with Concrete Sheet-pile

This analysis provided a comprehensive evaluation of slope reinforcement performance, ensuring the structure remained stable under both static and seismic (dynamic) loading conditions. The concrete sheet-pile was also modelled to know the global safety factor. The results of the stability model is shown in 8.

The analysis results indicated that the application of retaining structures, both cantilever walls and concrete sheet piles, significantly improved slope stability compared to the unreinforced condition. Under static loading, the factor of safety (SF) increased by approximately 17.9% for the cantilever wall and 12.5% for the concrete sheet pile relative to the unreinforced slope. Similarly, under pseudo static (seismic) loading, the SF improved by about 8.4% and 8.3%, respectively. The displacement values also exhibited a slight reduction after reinforcement, particularly under seismic conditions, indicating improvements not only in overall stability but also in deformation control.
