## Slope Stability Analysis Using GeoStudio-Based Finite Element Method

Landslides frequently occur in areas with steep slopes, high rainfall intensity, and human-induced land disturbances, posing significant risks to infrastructure and communities. This study investigates the soil characteristics and slope stability conditions of a landslide-prone area in Nagari Aia Dingin, Lembah Gumanti District, Solok Regency, Indonesia. The research employed field investigations, Standard Penetration Tests (SPT), laboratory testing, and numerical analysis using the GeoStudio-based Finite Element Method (FEM). Laboratory tests included water content, specific gravity, Atterberg limits, and grain size distribution to determine the physical properties and classification of the soil. The results indicate that the soil is predominantly classified as silty sand and silt (SM and ML) according to the Unified Soil Classification System (USCS), characterized by low cohesion and a high dependence on frictional resistance. Slope stability analyses were performed for slope angles of 30°, 45°, and 60° using GeoStudio. The calculated factors of safety (FS) ranged from 1.149–1.276 at 30°, 0.447–0.737 at 45°,

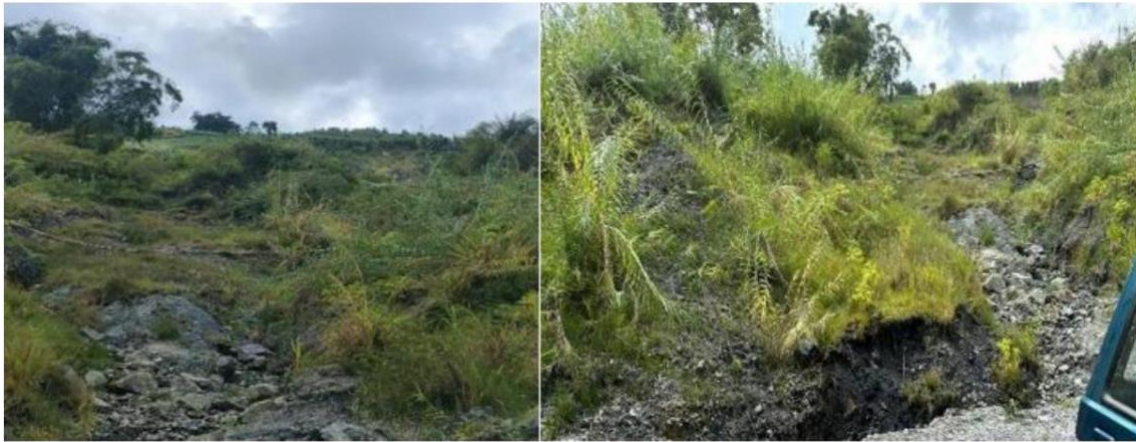
Figure 1. Condition of the slope after the landslide

The Alahan Panjang landslide disaster, precisely in the Air Dingin area, Lembah Gumanti District, Solok Regency, represents a typical case of rainfall induced slope failure exacerbated by anthropogenic activities. The event cut off the transportation flow between Solok Regency, South Solok, and Sungai Penuh, Jambi for seven days, causing significant socio-economic disruption and highlighting the vulnerability of critical infrastructure to geohazards (Minang, 2020). Hundreds of vehicles that usually pass through this route were halted, indicating the strategic importance of this corridor for regional connectivity. The 25 meter landslide not only disrupted

transportation but also caused the destruction of residential structures, as two local houses were swept away by landslide material originating from a mining excavation area located upslope. Although no fatalities were reported, the incident underscores the potential severity of combined natural and anthropogenic triggers in slope failure events. The chronology of the disaster began with continuous high intensity rainfall over a period of one week, which likely led to progressive saturation of the soil mass and a critical reduction in shear strength. Recent literature confirms that prolonged rainfall events are more dangerous than short intense storms because they allow deeper infiltration and sustained pore pressure build up, which ultimately leads to delayed but catastrophic slope failure (Kim et al., 2021; Luo et al., 2022).

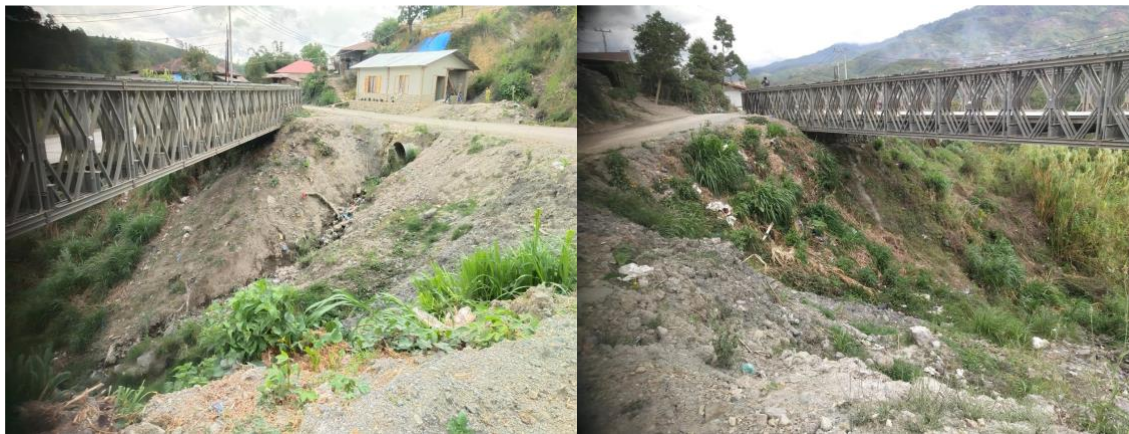
Figure 2. Condition after the slope after the landslide

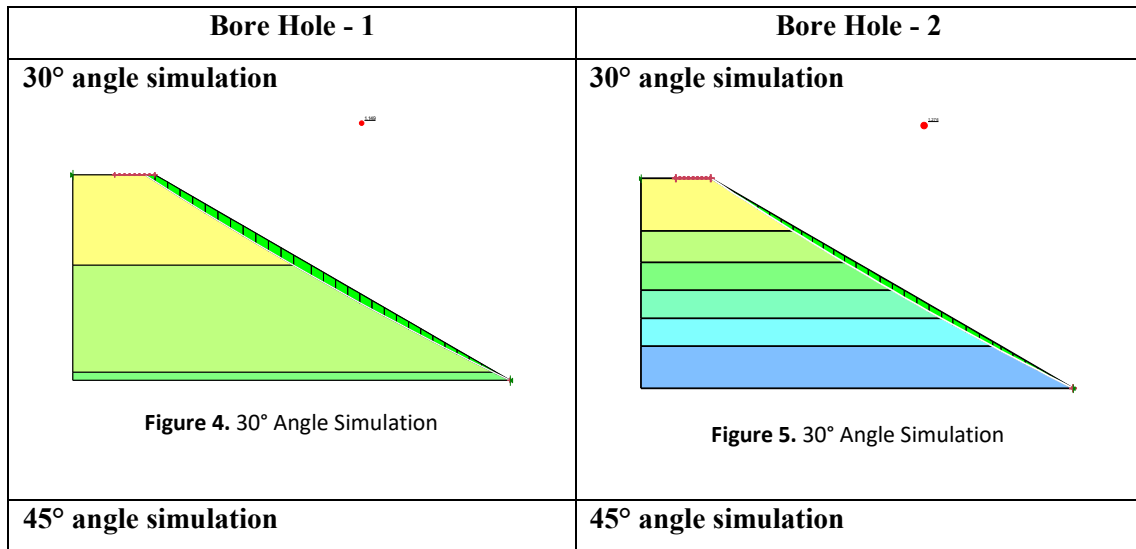
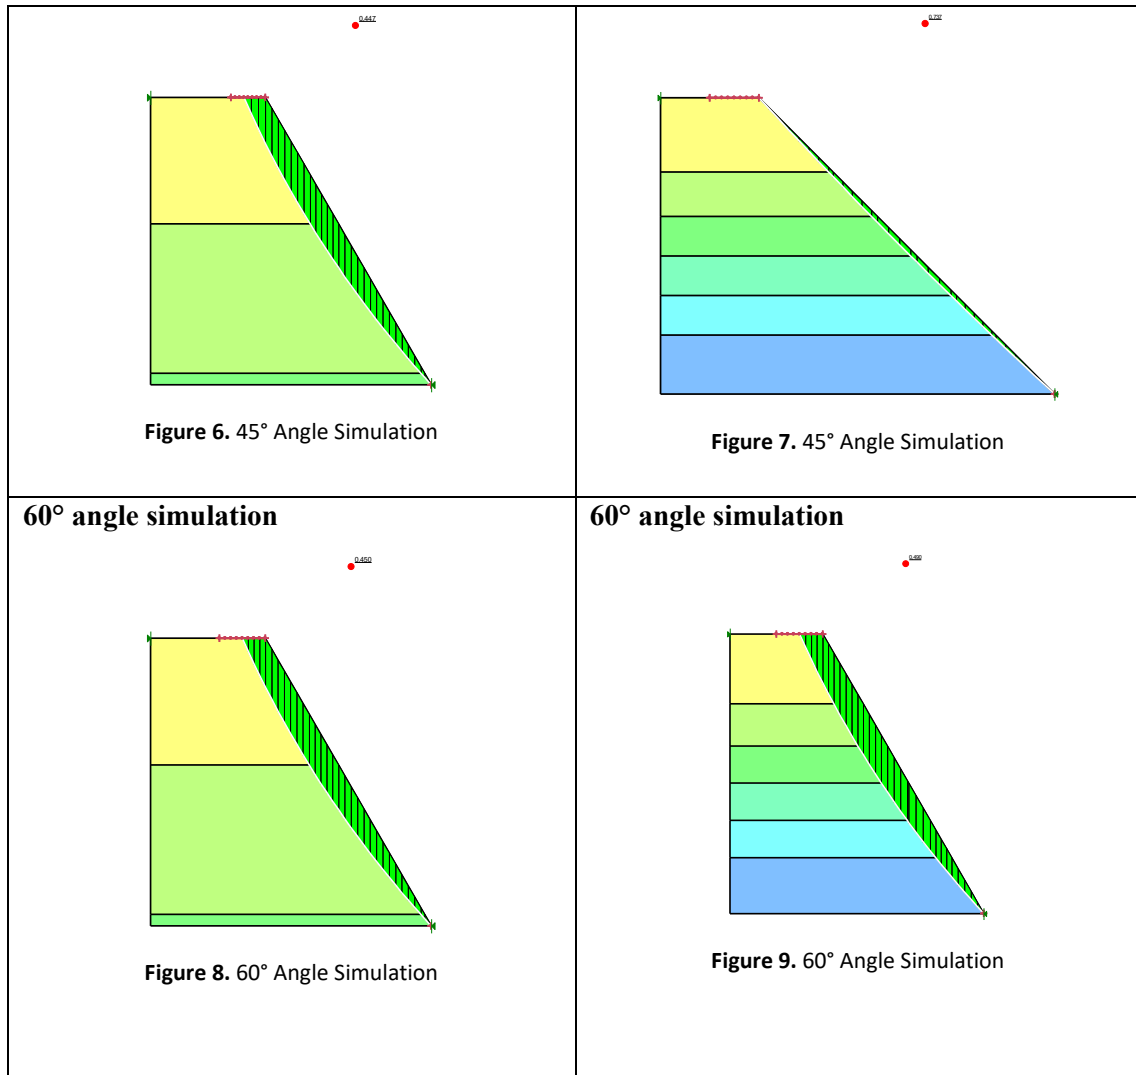
Next, a slope stability analysis was performed using GeoStudio software with slope angles of  $30^\circ$ ,  $45^\circ$ , and  $60^\circ$  in Figure 4. This simulation was conducted to determine the effect of variations in slope angle on the slope's factor of safety.

Figure 4. Slope stability analysis using GeoStudio software

The research location is in Nagari Aia Dingin, Lembah Gumanti District, at an altitude of approximately 1420 m above sea level (masl) with a slope ranging from 30° to 75°, so that the slope at this location can be categorized as a steep slope. Slope stability analysis was carried out using GeoStudio software to obtain the safety factor (FK) value at angles of 30°, 45°, and 60° slope inclination.

The simulation results show that the safety factor value decreases as the slope angle increases. At a slope of 30°, the FK value is 1.149 at BH – 01, FK 1.276 at BH – 02, at a slope of 45°, the FK value is 0.447 at BH – 01, FK 0.737 at BH – 02, at a slope of 60°, the FK value is 0.450 at BH – 01, FK 0.490 at BH – 02. Based on slope stability criteria, a slope is generally declared stable if it has a FK value  $\geq 1.5$ . Therefore, from the analysis results obtained, it can be concluded that the

slope at the research location is in an unstable condition at the analyzed slope angle because the safety factor value obtained is less than 1.5.
