Journal of Applied Civil Engineering and Practices

Analysis of Road Conditions Using the PCI and Bina Marga Methods on the Sanggau-Sekadau Section, West Kalimantan

Research paper

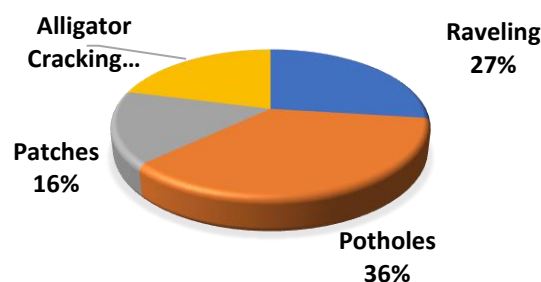
Figure 1. Diagram Percentage Road Damage

The damage observed in Sanggau-Sekadau at STA 20+000-22+000 and 32+000-39+000 can be categorized into four different types of damage. Potholes, Raveling, Alligator Cracking, and patches, and the Raveling that occurred on the road section can be seen in Figure 1 that most of the damage is dominated by Pothole damage, Potholes 36%, then Raveling 27%, Alligator Cracking 21%, and finally Patches 16% of the total road damage samples.

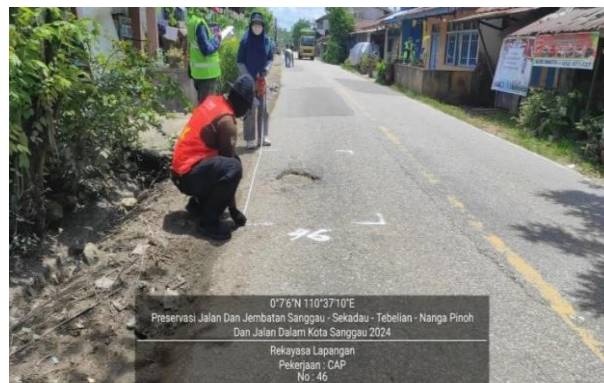
Figure 2. Damage Patches

Patches on the surface of the road happen because of various factors that are mutually related. First, the pressure of heavy vehicle Which passing by can damage the surface road. Then, use material of low or Improper mixing of road layers also worsens the situation. Environmental factors, like extreme weather, are also influential because changes in temperature and rainfall accelerate damage. In addition, the system drainage causes water to flood, so that it speeds up the damage to the surface. Combining all factor This results in damage in the form of patches in the road. Damage to patches is measured according to their diameter. example Wrong One patches damage. This happened on the road limit in Sanggau-Sekadau city, West Kalimantan. STA 2+000 damage happen edge of the pavement

Damage patches happen throughout STA 20+000-24+000, and STA 32+000-39+000, with total damage. Potholes, 50-point patches from the results of the patches analysis, are the most dominant damage with 36%, compared to other example damage, which can be seen in Figure 2 below.

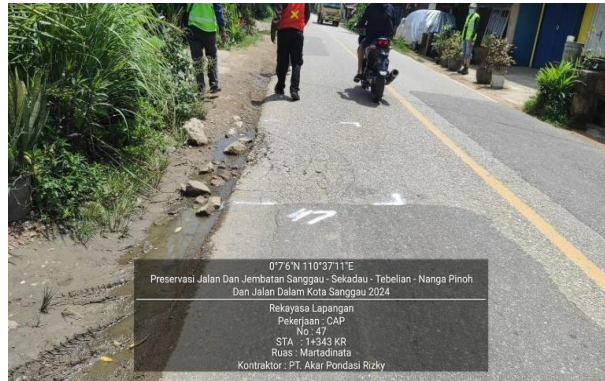
Figure 3. Damage Alligator Cracking

Cracks on the road surface often occur due to the use of coating materials that do not meet quality standards. In addition, unstable or low-moisture base soil, Which No in accordance Also can also become the cause. Other factors that play a role include extreme temperature changes, vehicle load, as well as the influence of the weather and environment around. The interaction between these various factors can worsen road conditions, so analysis is needed. in-depth to identify the root cause and find the right solution. An example of one of the Alligator Cracking damages occurred on the Sanggau-Sekadau city boundary road in Kalimantan city, west STA 2+000 damage happen edge of the pavement.

Level of Damage	Damage Identification
Medium	Crack pattern is parallel to each other, with lines connecting and random cracks. For damage road, this is classified as damage currently

Alligator Cracking Damage occurs throughout STA 20+000- 24+000 and STA 32+000-39+000 with total damage that is 29 poin Alligator Cracking, which can be seen on Table 1. The results of the analysis showed quite a lot of damage, Potholes 21% of the total damage. For example, damage can be seen in Figure 3, following this.

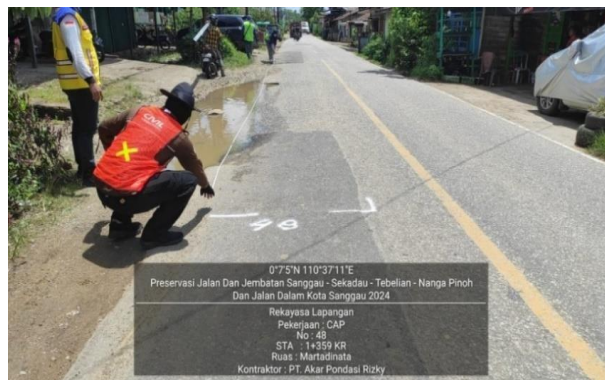
Figure 4. Patch Damage and excavation

One of the causes of patch damage is the application of an inappropriate installation method, so that the patch surface becomes uneven or not parallel to the surrounding area. This imperfection can occur due to a lack of compliance with the correct installation procedures or the use of materials that do not meet standards. As a result, the patch becomes unstable, reducing the comfort of road users and triggering further damage to the road infrastructure. An example of one of these patch damages occurred on the Sanggau-Sekadau city boundary road, Kalimantan West. STA 2+000 damage happen edge pavement, which can be seen in Figure 4 and the description in Table 2 below.

Level of Damage	Damage Identification
High	The patch is slightly damaged, and the comfort of the driver is disturbed. For the patch on the BTS Sanggau-Sekadau STA 2+000 road with an area of 1.3 m, it is categorized as High Severe damage

Patch damage occurred along STA 20+000-24+000 and STA 32+000-39+000, with a total damage of 22 patch points from the analysis results, which is quite a lot of damage, with 16% of the total damage. An example of the damage can be seen in Figure 4 below.

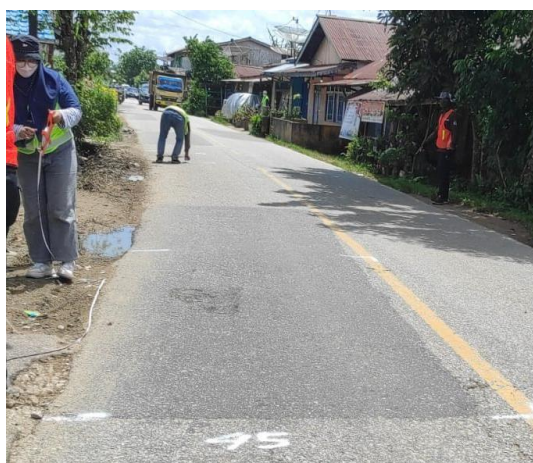
Figure 4. Damage Release Details

Granular Detachment is damage to the road surface caused by various factors, one of which is high traffic load. This excessive load inhibits the optimal integration process in the road

foundation layer. As a result, the asphalt layer on the top is damaged until the asphalt is released from the wearing layer. Condition: This impact on the decline in quality and overall road safety, so evaluation and repair are needed to prevent further damage in the future. an example of one of these granular release damages occurred on the Sanggau-Sekadau city boundary road, West Kalimantan City. STA 2+000 damage occurred at the edge of the pavement, which can be seen in Figure 5 and the description in Table 3 as follows.

Level of Damage	Damage Identification
High	In the form of Surface Paving Which Rough Texture Many also lose the grain between >10%, the area lost, aggregate type damage, this goes into the level Heavy

Raveling Damage occurs along STA 20+000- 24+000, and STA 32+000-39+000 with total damage that is 38. The point of grain release from the analysis results shows quite dominant damage, with Potholes 27% of the total damage.
