Electrical Resistivity Tomography as a Geotechnical Justification Support (Case Study Makassar – Pare-Pare Railway Bed Construction KM 68+450 to KM 68+750)

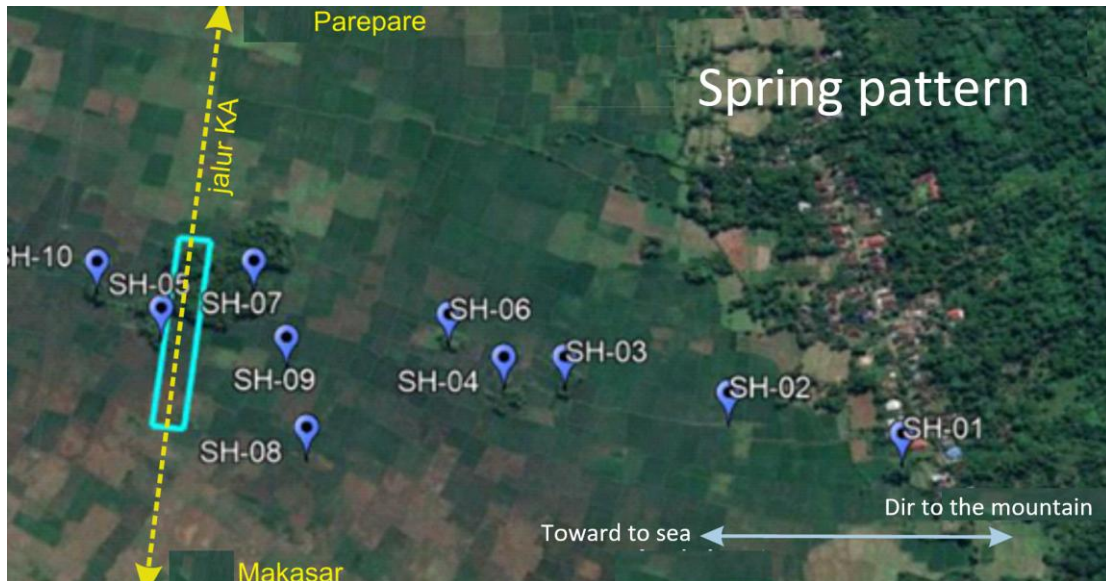
c) Around the research location, there was a hole/reservoir that was always filled with water as seen in Figure 8, which was estimated to be a sinkhole.

f) There was a pattern of 10 spring gaps (estimated to be sinkholes) running from east to west or from the mountain towards the sea.

**Figure 8**. Reservoir Patterns around the Research Location

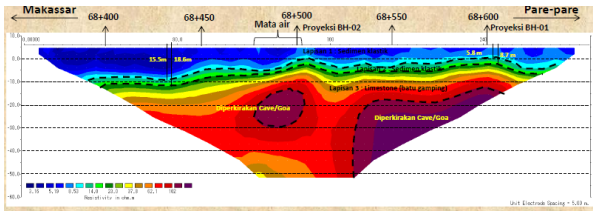
Figure 10. Resistivity Visualization Line 1

The ERT test in Line 1 results that the first layer had a resistivity value of 2.89 - 11 Ωm with a depth varying from 5.2 - 16.3 meters from the surface. The second layer had a resistivity value of 11 - 18 Ωm with a depth of 7.3 - 19.4 meters from the surface (thickness of 2.1 - 3.1 meters). The third layer had a resistivity value of 18 - 201.93 Ωm.

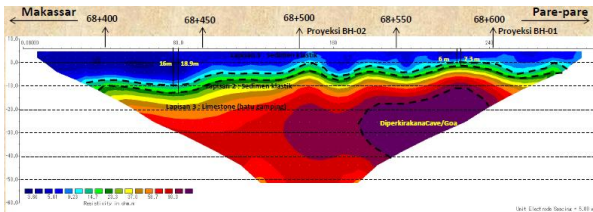
Figure 11. Resistivity Visualization Line 2

The ERT test in Line 2 results that the first layer had a resistivity value of 3.26 – 11 Ωm with a depth varying from 6 – 16 meters from the surface. The second layer had

a resistivity value of 11 – 18 Ωm with a depth of 7.3 – 18.9 meters from the surface (thickness 1.3 – 2.9 meters). The third layer has a resistivity value of 18 – 166.34 Ωm.

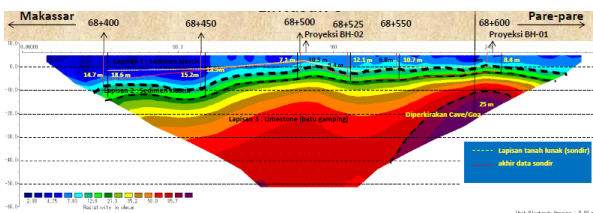
**Figure 12**. Resistivity Visualization Line 3

The ERT test in Line 3 results that the first layer had a resistivity value of 2.54 - 10 Ωm with a depth varying from 6 - 16 meters from the surface. The second layer had a resistivity value of 10 - 17 Ωm with a depth of 8 - 20 meters from the surface (thickness 2 - 4 meters). The third layer had a resistivity value of 17 - 179 Ωm.

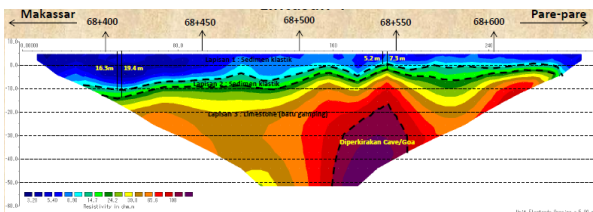
**Figure 131.** Resistivity Visualization Line 4

The ERT test in Line 4 results that the first layer had a resistivity value of 2.89 – 11 Ωm with a depth varying from 5.2 – 16.3 meters from the surface. The second layer had a resistivity value of 11 – 18 Ωm with a depth of 7.3 – 19.4 meters from the surface (thickness 2.1 – 3.1 meters). The third layer had a resistivity value of 18 – 201.93 Ωm.

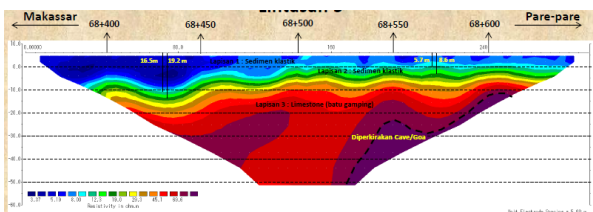
Figure 14. Resistivity Visualization Line 5

The ERT test in Line 5 results that the first layer had a resistivity value of 3.02 – 10 Ωm with a depth varying from 5.7 – 16.5 meters from the surface. The second layer had a resistivity value of 10 – 14 Ωm with a depth of 8.6 – 19.2 meters from the surface (thickness 2.7 – 2.9 meters). The third layer had a resistivity value of 14 – 119.08 Ωm.

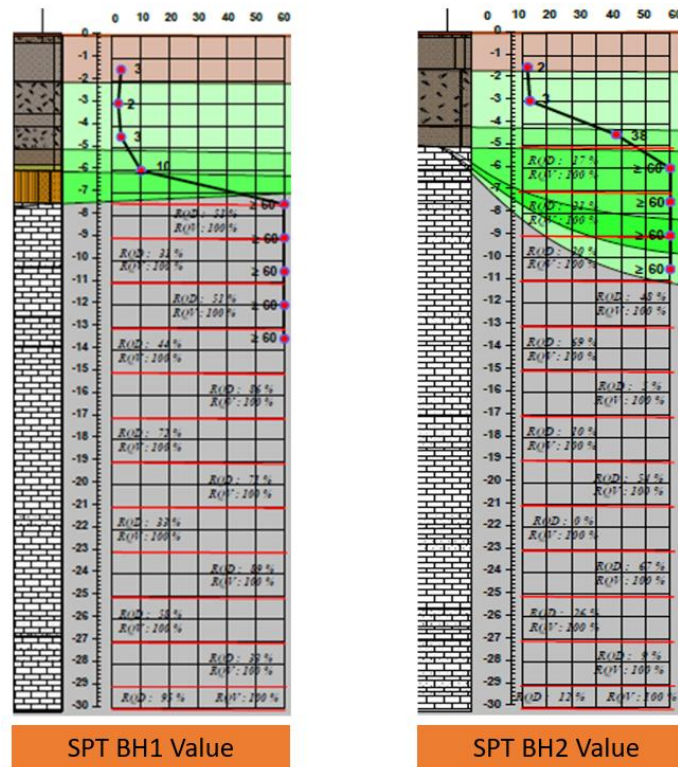
The results of the BH 1 test as shown in Figure 16 were that a new bedrock was found in limestone at a depth of 7.4 m from the original soil. For a soil layer of 7.4 m, most of it consists of clay with a little fine sand. In the soil layer in BH 1, the N-SPT value was relatively low, ranging from 3-10, indicating that the soil layer is quite soft. In the investigation >7 m, limestone rock structures were obtained with varying conditions.

In BH 2 can be seen in Figure 16, limestone bedrock was found at a depth of 5 m from the original soil. In this surface layer of soil, most of the material is clay mixed with fine sand with SPT values of 2 and 3. For BH 1 and BH 2, the rock layers obtained SPT values >60. Figure 17 and Figure 18 show the Borehole Log of BH1 and BH2.

Figure 16. Sketch of Soil Layer based on Boring and SPT Testing.
