## Design Analysis of Pancanaka 2000 Tooth Bucket Structure Using Finite Element Method

| ARTICLE INFO | ABSTRACT |
|---|---|
| <b>Keywords:</b><br>Tooth bucket; Finite element analysis; Excavator; Cracking area | |

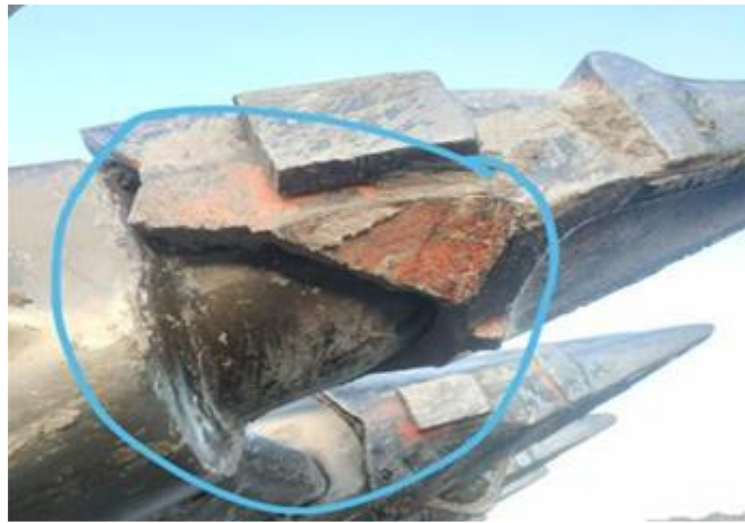
The problems I encountered with the Pancanaka 2000 tooth bucket involved several important technical aspects, including damage to the bottom of the tooth bucket, unstable conditions during installation, and repeated fractures over a relatively short period (by hour

meter) can be show in Fig. 1. In addition, erosion resulted in a rounded tooth shape and made it difficult to penetrate the material, especially when 70% of the tooth length remained. These issues indicate design or material deficiencies that impact the durability and performance of the bucket teeth in difficult operational situations [10].

**Figure 1.** The tooth bucket bottom was broken

The cause of damage to the tooth bucket can be identified through several technical factors. One of them is excessive endplay dimensions, which result in uncontrolled movement and instability during operation. The design of tooth side angles that are too sharp can also accelerate the wear process and cause damage to the structure [11]. Additionally, undetected laminations can reduce the material's strength, thereby increasing the likelihood of fracture [12]. The high hardness of the material makes the tooth more susceptible to cracks. At the same time, worn adapters contribute to malfunction, as they reduce the effectiveness and stability of the tooth's joining under severe working conditions.

- 3) Factors that cause the Pancanaka 2000 tooth bucket to break include material erosion of the tooth adapter, resulting in the tooth bucket gap exceeding the tolerance limit (0.5 mm to 1.5 mm), and environmental factors that affect operational units in two areas: rocky and sandy. In rocky conditions, the tooth bucket often breaks on its back. The tooth bucket is corroded in sandy conditions, or the tip is blunted quickly.

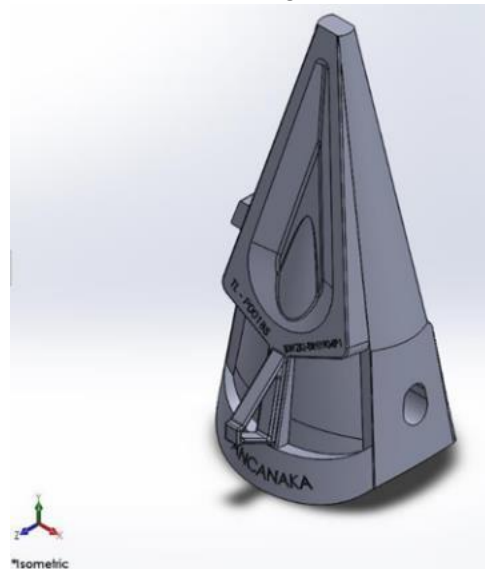
Through the Shining 3D software, the original shape of the tooth bucket can be identified. A three-dimensional representation can be generated and converted into the format to be applied in this study, as shown in Fig. 2. Three-dimensional data of the Pancanaka 2000 tooth bucket was collected using the Shining 3D software, which scans a physical object to generate a highly detailed 3D model with X, Y, and Z coordinate axes in the desired direction. Despite being relatively new, this 3D scanning technology is considered accurate, fast, and effective. The scanning procedure was conducted according to SOPs to ensure data accuracy and consistency. The resulting 3D model serves as the basis for the testing and simulation stage, utilizing Ansys software to analyze product performance through simulations of material strength, load resistance, and environmental impact. These simulations aim to ensure the product meets quality standards and provide insights for further development.

**Figure 2.** 3D scan results have been converted

Three-dimensional data of the Pancanaka 2000 tooth bucket were collected using Shining 3D software, which scans physical objects to produce highly detailed 3D models in the desired direction along the X, Y, and Z coordinate axes. Despite being relatively new, this 3D scanning technology is considered accurate, fast, and effective. The scanning procedure was conducted according to SOPs to ensure data accuracy and consistency. The resulting 3D model serves as the basis for the testing and simulation stage, utilizing Ansys software to analyze product performance through simulations of material strength, load resistance, and environmental impact. These simulations aim to ensure the product meets quality standards and provide insights for further development. The approach applied in testing the tooth bucket structure is through simulation modeling. This method analyzes the cracking area as part of the test. The cracking area analysis stage displays the overall simulation conditions, including the bucket used at the site, which has a capacity of 13.7 m<sup>3</sup>, allowing for a material lift of 20 tons per lift. When digging 10 tons, the converted load is 98,066 N.

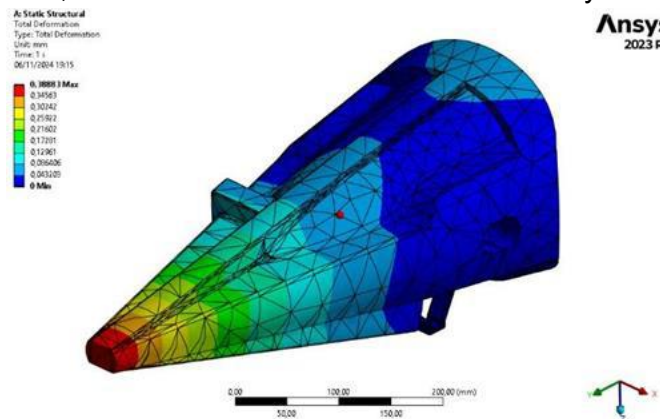
**Figure 3.** Total deformation results

Based on Fig. 3, it can be seen that the red contour shows a high deformation rate of 0.38883 mm. This value reflects a minimal deformation of less than 1 mm, which allows the tooth bucket to return to its original position. Meanwhile, the lowest deformation value was recorded at 0 mm at the back of the bucket tooth, indicating that the area was not subjected to significant stress. In von Mises stress, there is a relationship between the loading conditions and the stress distribution in the material, so a simulation is performed to illustrate the value of von Mises stress. The von Mises stress is an indicator to assess the possibility of material failure by analyzing the results of the three main stresses, which are often referred to as principal stresses. Material failure can be predicted when the von Mises stress value exceeds the yield stress of the material ( $\sigma_v > \sigma_y$ ).

The results of the total displacement analysis show that the largest deformation occurs at the tip of the bucket tooth, where this elastic condition allows the material to return to its original position after the load is released. The maximum deformation value measured reached 0.38883 mm. In comparison, the lowest deformation value was 0 mm, indicating a variable load distribution on the component. This indicates that the tip of the tooth bucket is the most vulnerable area to deformation due to the working load. However, the deformation that occurs remains within reasonable limits for the material used, consistent with its elasticity characteristics. Sun, Yuan, et al. [15] stated that the tip of the tooth bucket often experiences the highest deformation when it receives the maximum working load under digging conditions. The safety factor indicates that the construction has a better and stronger ability to withstand loads, ensuring the structure can withstand extreme conditions. The maximum safety factor value measured reached 15, indicating that the structural design is significantly stronger than the facing load. Meanwhile, the low safety factor value of 1.328 indicates that the minimum safety factor result is still below the set 1.5, considering material safety aspects [13, 16].

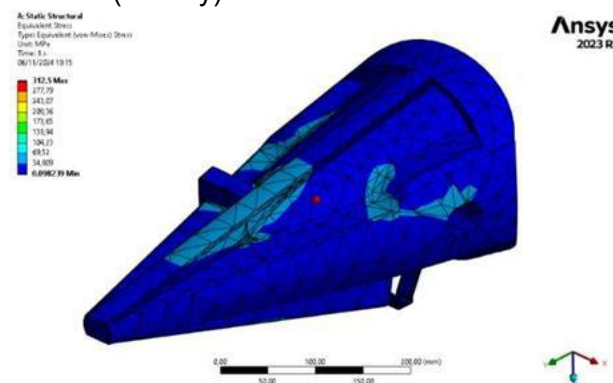
**Figure 4.** Von misses the stress results

In Fig. 4, the von misses stress analysis shows that the largest stress occurs inside the bucket tooth, which functions to withstand the load during the excavation process. The maximum measured stress value reached 312.5 MPa. Meanwhile, the low-stress value is 0.0982 MPa. An important parameter that supports static structural analysis is the safety factor. The safety factor plays a crucial role in ensuring that the system remains safe when facing loads exceeding calculations, so the design does not fail under these conditions. A higher safety factor value indicates that the construction has a better and stronger ability to

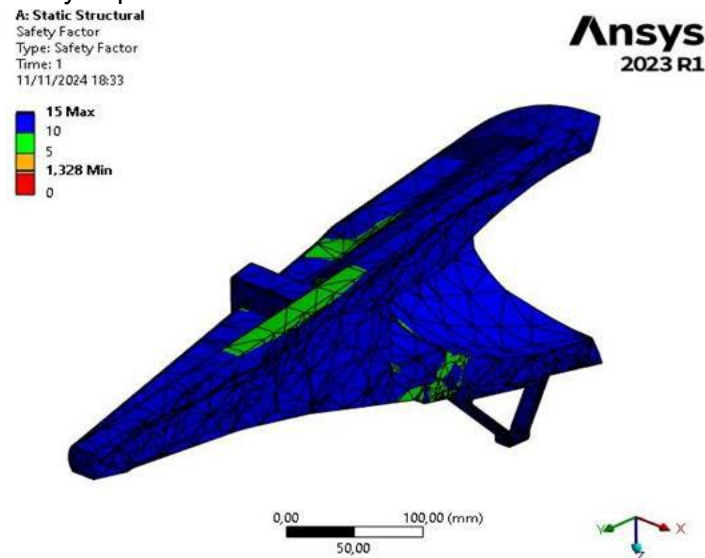
**Figure 5.** Safety factor analysis results

Fig. 5 shows that the highest safety factor value reaches 15 in the control zone area and its surroundings, which are marked in several annotated sections. Meanwhile, the low safety factor value is 1.328 in the safety zone. Although some elements fall below the minimum standard, this does not affect the existing loads. The analysis results show that von misses stress occurs inside the bucket tooth, which functions to withstand the load during the excavation process. The maximum measured stress value reached 312.5 MPa, while the lowest was only 0.0982 MPa. According to the data, the maximum stress that occurs is still below the characteristic yield strength of AISI 4140 material, which is 655 MPa. This shows that the material can withstand the workload. However, areas with high stress still require special attention to prevent potential damage in the future [14].
