## Design and Finite Element Analysis of a Portable Bus Service Ramp to Reduce Dependence on Service Pits

Novian Dhamas Ramadhan<sup>1</sup>, Muhammad Alfarizi<sup>1</sup>, Agus Widyianto<sup>1\*</sup>

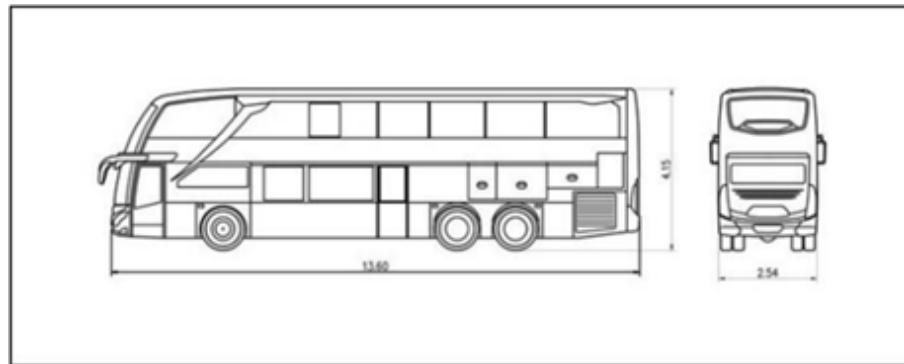
**Figure 3.** Bus Dimensions

The Scania K410 is 13.60 meters long and is suitable for accommodating more passengers on both floors. At 4.15 meters tall, this bus is a double-decker model that

offers comfortable seating on the upper deck. Its width of 2.54 meters, in accordance with intercity bus standards, provides adequate space for two rows of seats and maintains stability and comfort during the journey.

The Scania K 410 bus has an uneven weight distribution across its rear axles, requiring a working load capacity of 18,100 kilograms (Fig. 3). This is one of the specifications that is effectively articulated. The load is allocated according to the bus's actual weight distribution, with 42% on axle 2 (7,602 kg) and 58% on axle 3 (10,498 kg). Portability requirements are critical, given the limited workspace and the need to move the ramp between repair areas.

The Measure phase compiles the technical data that forms the basis for the portable ramp design calculations. The Scania bus specifications show dimensions: length 13.60 meters, width 2.54 meters, and a total weight of 29 tons, with a load of 18,100 kg, distributed to axles 2 and 3 at 42%:58%, in accordance with the actual load distribution between the axles. Each load on the axle is assumed to be evenly distributed between the right and left sides (ratio 50:50), so that each ramp is designed to bear a load of 9,050 kg under maximum loading conditions.

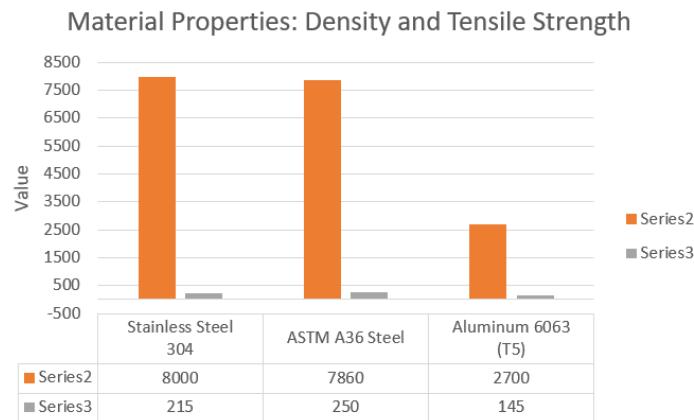
**Figure 4.** Material Graph

Based on the specified material specifications, a comparison was made using a Fig. 4 to assess the relative performance of each material.

After conducting a comprehensive material analysis using the Ashby Material Chart, it was concluded that there are three candidate materials: ASTM A36 Carbon Steel, SS 304 Stainless Steel, and Aluminum 6063, which emerged as the most suitable choices based on the strength-to-weight index. It was concluded that the materials in Table 3 below are the most suitable alternatives.

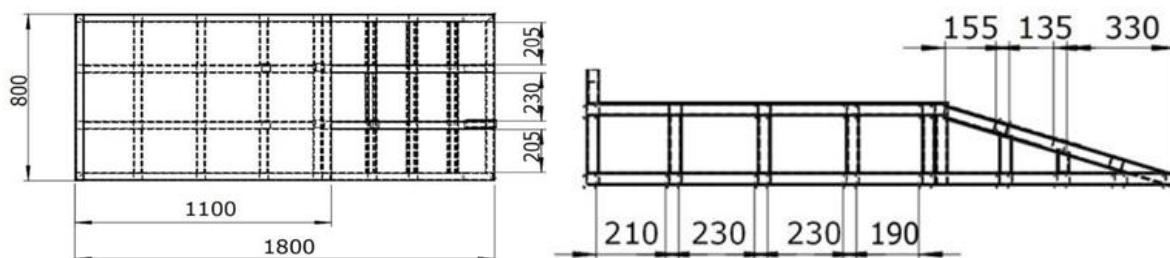
**Figure 5.** 2D Drawing

The final design features an optimized rib configuration for more even stress distribution. The ribs are strategically placed at intervals of 135- 230 mm along the length of the ramp to optimize the strength-to-weight ratio. Material thickness was optimized from 4 mm to 2 mm for selected materials, reducing the ramp's total weight without compromising structural integrity and accounting for market availability (Fig. 5).

Safety barriers (stoppers) are 10 cm high and placed at the front of the ramp to prevent wheels from leaving the ramp area. The stopper design functions as a wheel guide and additional safety feature. The ramp surface features diamond-patterned steel plates to improve traction and prevent slipping in wet or oily conditions. The diamond pattern, with

a height of 2 mm, provides optimal grip without damaging vehicle tires.

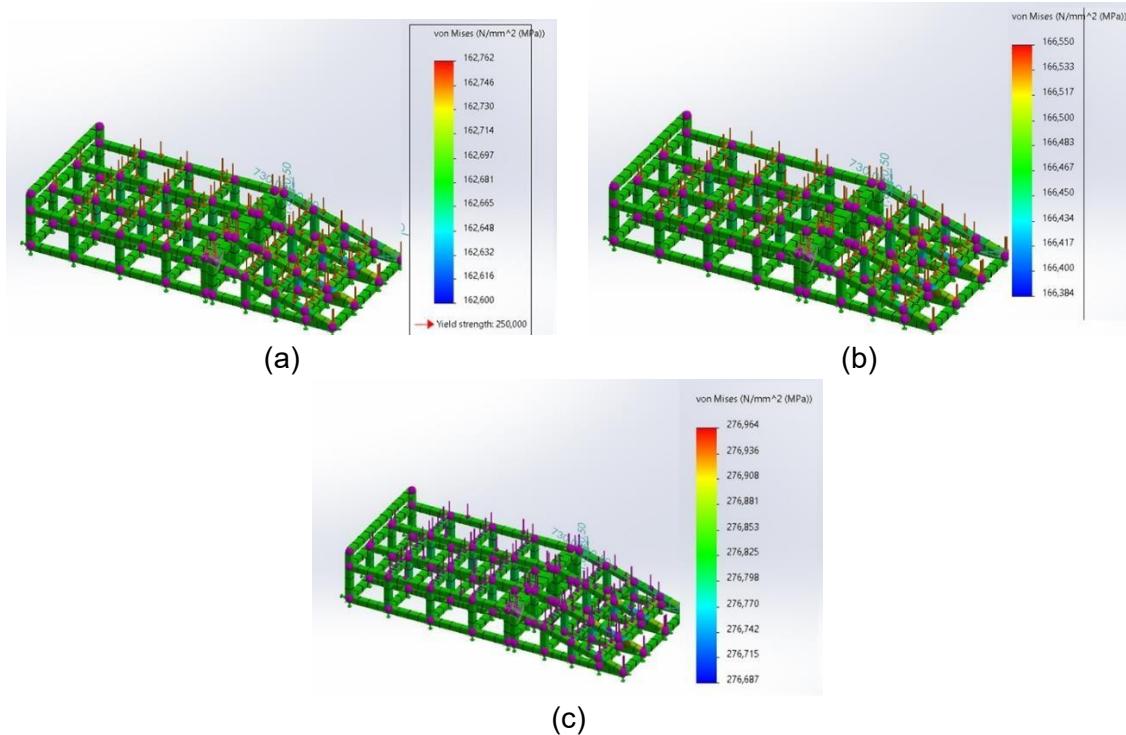
**Figure 6.** Von Mises stress of a) ASTM A36 Steel, b) Stainless Steel SS 304, and c) Aluminum 6063

The FEA simulation results show that the von Mises stress distribution (Fig. 6) is within safe limits for both candidate materials. The maximum stress occurs in the load-concentration area (the point of contact between the wheel and the surface ramp). It is significantly lower than the material's yield limit. For ASTM A36 Carbon Steel, the maximum von Mises stress recorded was 162.762 MPa, well below the 250 MPa limit.

No	Material	Stress		
		Specification (MPa)	Simulation (MPa)	Conclusion
1	Carbon steel ASTM A36	250	162.762	No plastic deformation occurred, and the material was in a safe condition
2	Stainless steel AISI 304	210	166.550	No plastic deformation occurred, and the material was in a safe condition
3	Aluminum 6063 (T5)	145	276.964	Plastic deformation occurred, and the material was in an unsafe condition
